**REPORT OF  
WINTER 1996/SUMMER 1996  
FLEXIBLE DELINEATOR  
IMPACT TESTING**

**NTPEP 124**

**October 1996**

**TENNESSEE DEPARTMENT OF TRANSPORTATION**

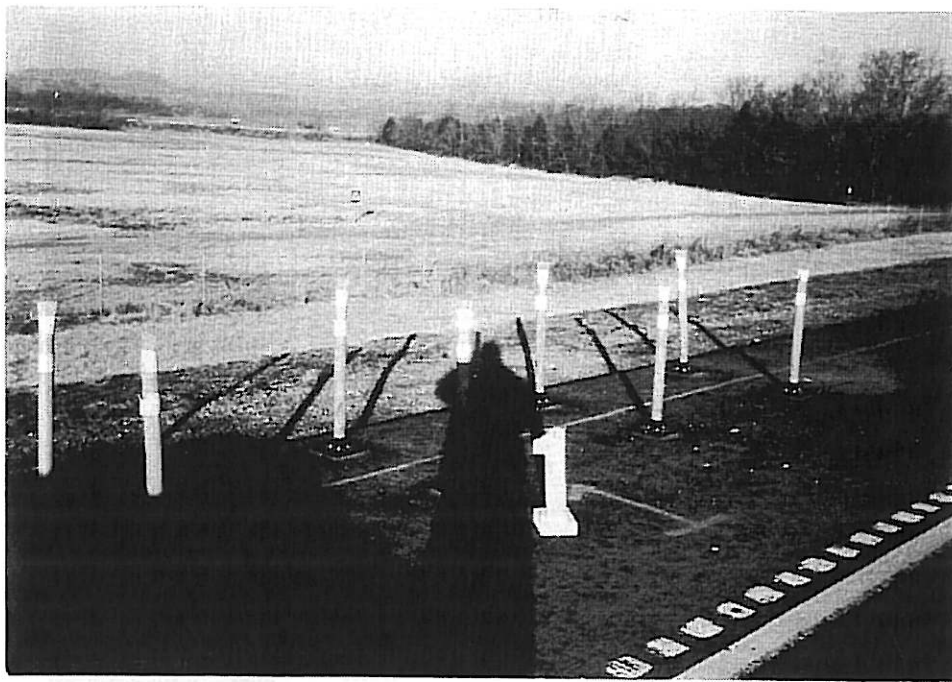
ONE WINTER IMPACT COMPLETED

- #1 Impact: Sheeting adhesive on post #4, 5 and 6 began stripping off. Post #4, 6, 7 and 8 had 10% sheeting damage. Post #5 had 15% sheeting damage.
- #2 Impact: Post #1 and 2 had 5% sheeting damage. Post #3, 7 and 8 had 15% sheeting damage. Post #4 had 40% sheeting damage. Post #5 had 50% sheeting damage. Post #6 had 30% sheeting damage.
- #3 Impact: Post #2 had 15% sheeting damage. Post #4 and 5 had 80% sheeting damage. Post #3 had 25% sheeting damage. Post #6 and 8 had 45% sheeting damage. Post #7 had 30% sheeting damage.
- #4 Impact: Post #3 and 6 had 60% sheeting damage. Post #2 had 30% sheeting damage. Post #5 had 85% sheeting damage. Post #7 and 8 had 40% sheeting damage.
- #5 Impact: Post #2 and 7 had 40% sheeting damage. Post #4, 5 and 8 had 85% sheeting damage. Post #6 had 100% sheeting damage. Post #3 had 75% sheeting damage.

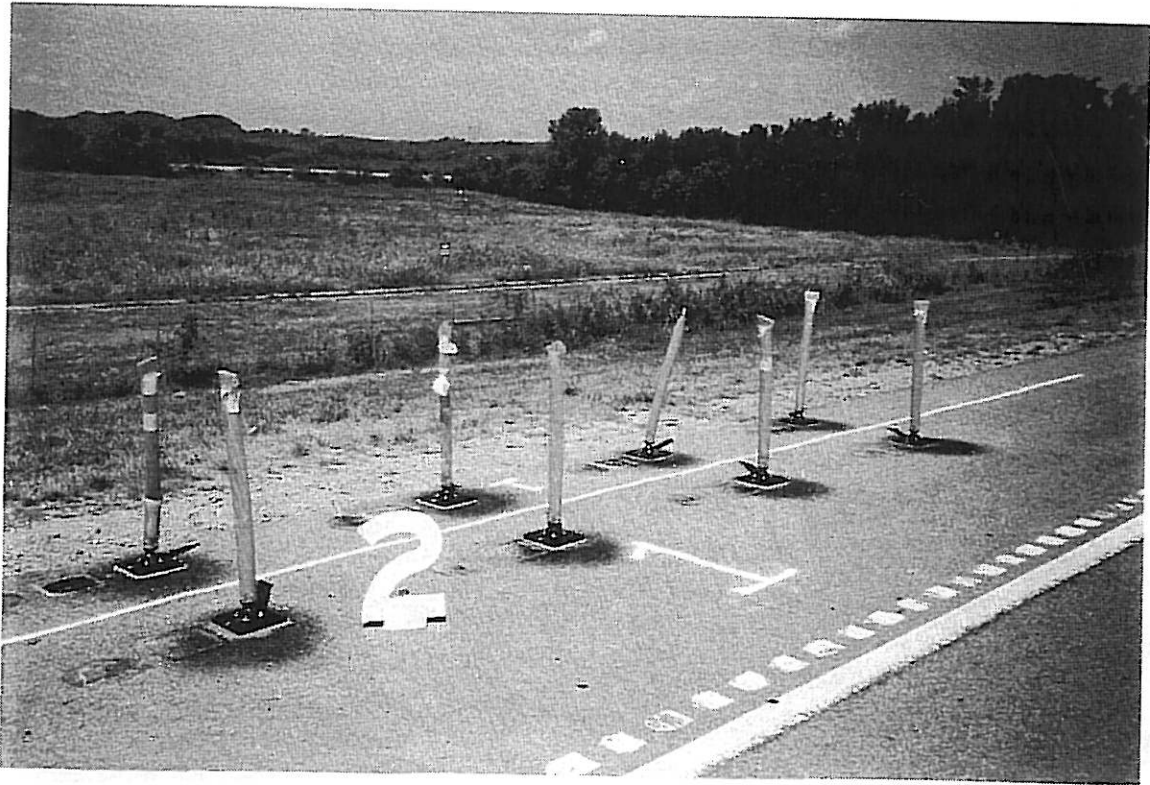
FIVE WINTER IMPACTS COMPLETED  
TWO SUMMER IMPACTS COMPLETED

- #1 Impact: No further damage noted.
- #2 Impact: Post #4 had 90% sheeting damage.
- #3 Impact: Post #1 had 80% sheeting damage. Post #3 had 100% sheeting damage.
- #4 Impact: No further damage noted.
- #5 Impact: No further damage noted.

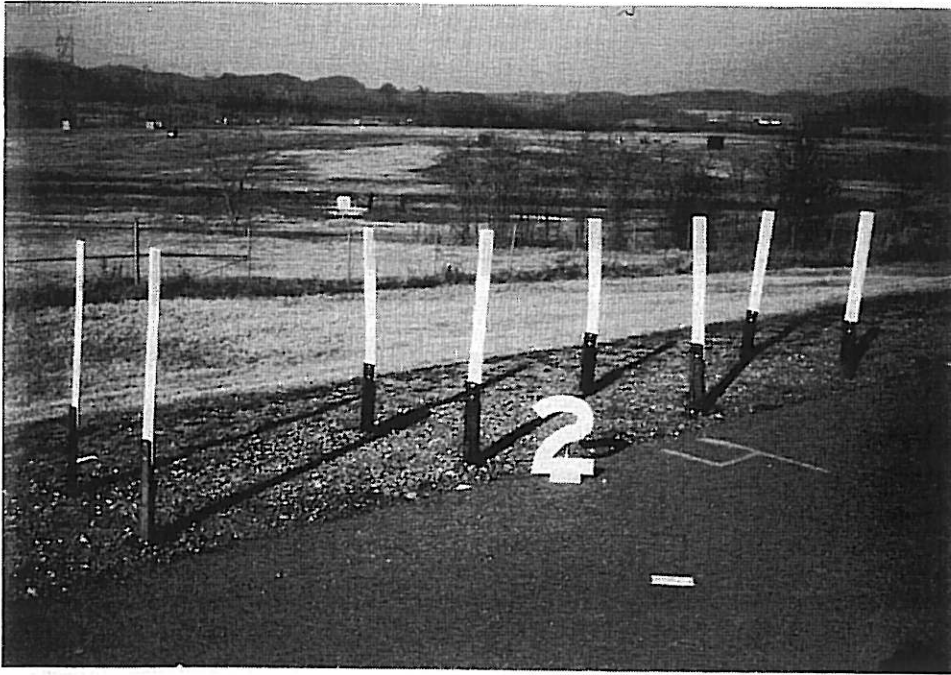
TWO WINTER IMPACTS COMPLETED

#2 Impact: Post #1 had 60% sheeting damage. Post #2 had 10% sheeting damage.

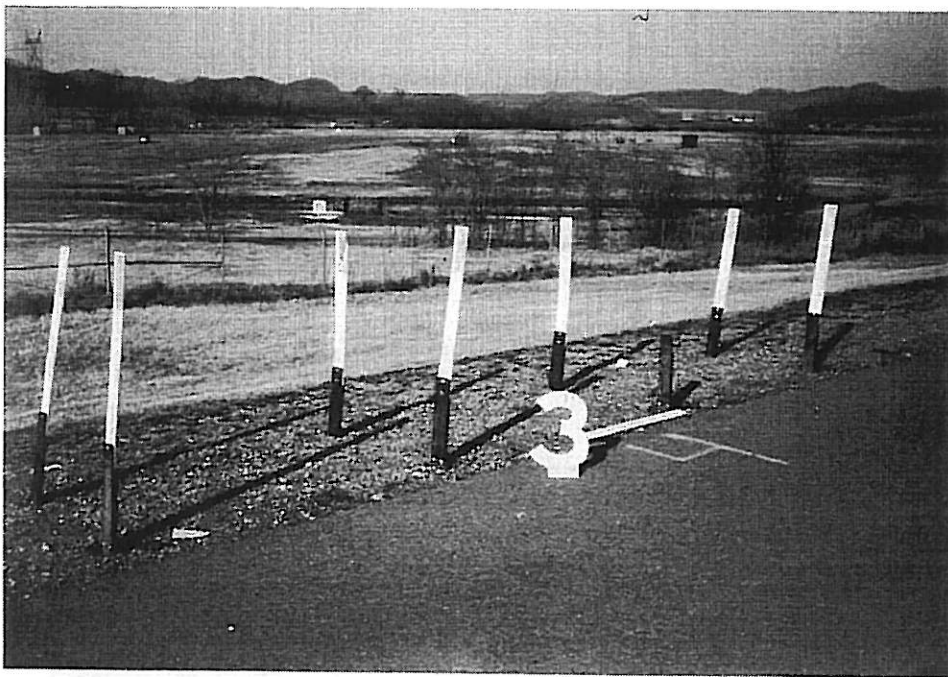
THREE WINTER IMPACTS COMPLETED

#3 Impact: Post #2 had 20% sheeting damage. Post #3 had 60% sheeting damage. The entire upper plastic section of post #7 was torn off. Post #5, 6, 7 and 8 pulled up 1 inch.

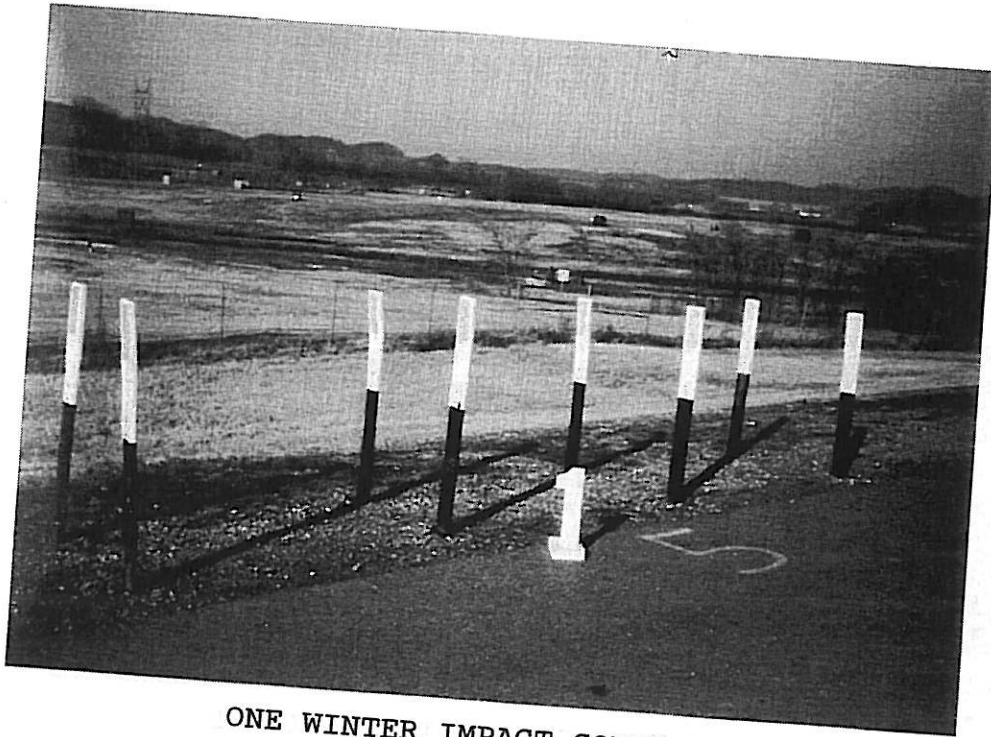
ONE WINTER IMPACT COMPLETED

- #1 Impact: No sheeting damage was noted. Post #2, 4, 6, 7 and 8 developed splits along the sides of the plastic casing.
- #2 Impact: Post #6 and 8 had 100% sheeting damage. Post #5 had 50% sheeting damage. The front part of the plastic casing on post #6 tore off. Post #2, 3, 4, 7 and 8 further developed splits along the sides of the plastic casing.
- #3 Impact: Post #2, 4 and 5 had 100% sheeting damage. Post #3 had 60% sheeting damage.
- #4 Impact: The remaining upper portion of post #6 tore off.
- #5 Impact: Post #7 had 40% sheeting damage.

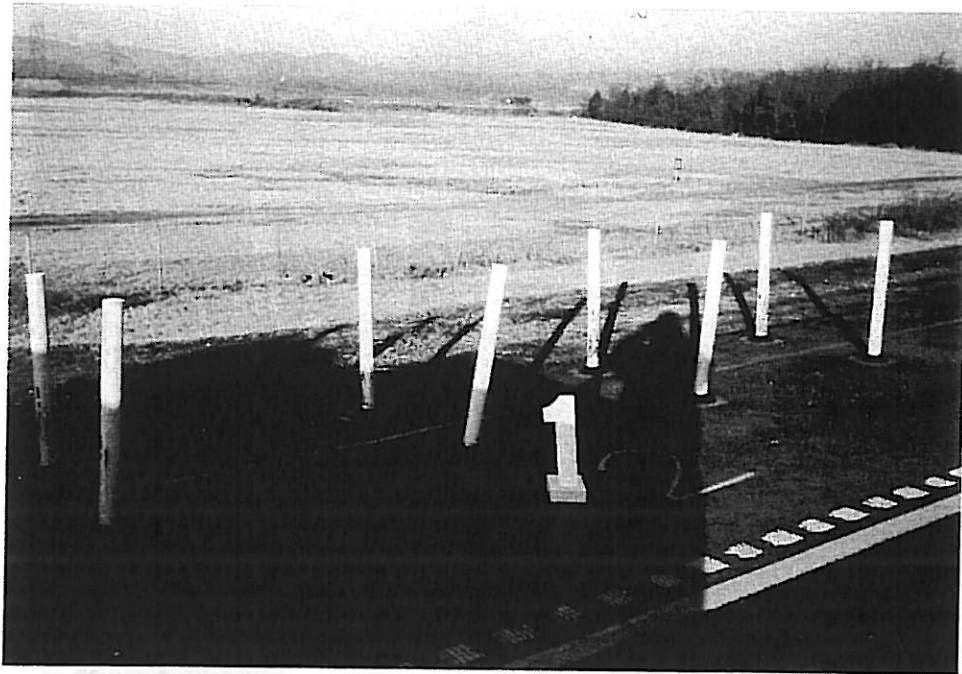
ONE WINTER IMPACT COMPLETED

#1 Impact: Post #7 had 10% sheeting damage. Post #6, 7 and 8 developed a 6 inch crack at the top.

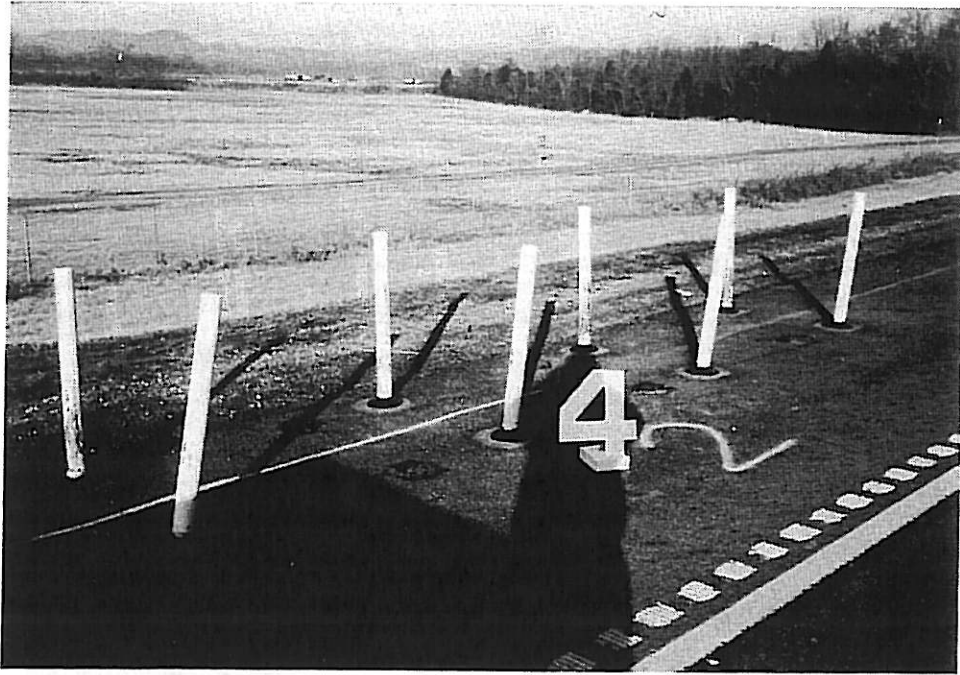
FOUR WINTER IMPACTS COMPLETED

#4 Impact: Post #5 had 15% sheeting damage. Post #6 and 7 had 20% sheeting damage.

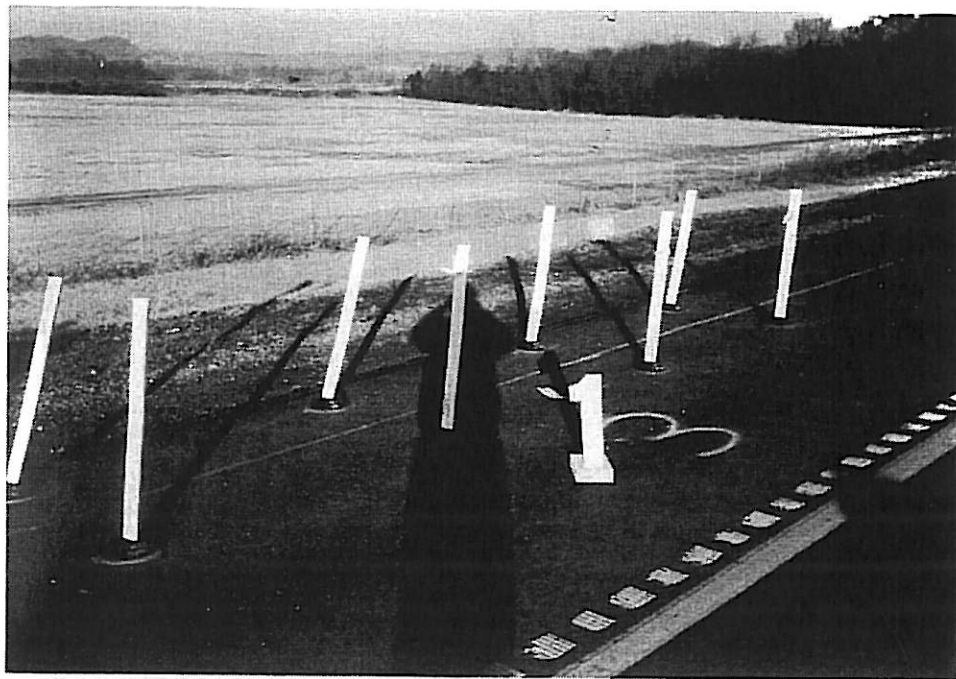
ONE WINTER IMPACT COMPLETED

- #1 Impact: Post #5 had 100% sheeting damage. Post #6 had 60% sheeting damage.  
 Post #7 and 8 had 40% sheeting damage. A crack started to develop at the bottom of post #1, 2, 3 and 4
- #2 Impact: Post #2, 3, 6, 7 and 8 had 100% sheeting damage. Post #4 tore out at the base.
- #3 Impact: No further damage was noted.
- #4 Impact: No further damage was noted.
- #5 Impact: No side readings could be obtained on post #1 and 2. Post #3 bent down flat on the ground. The tear at the bottom of Post #1, 2 and 3 became more severe.

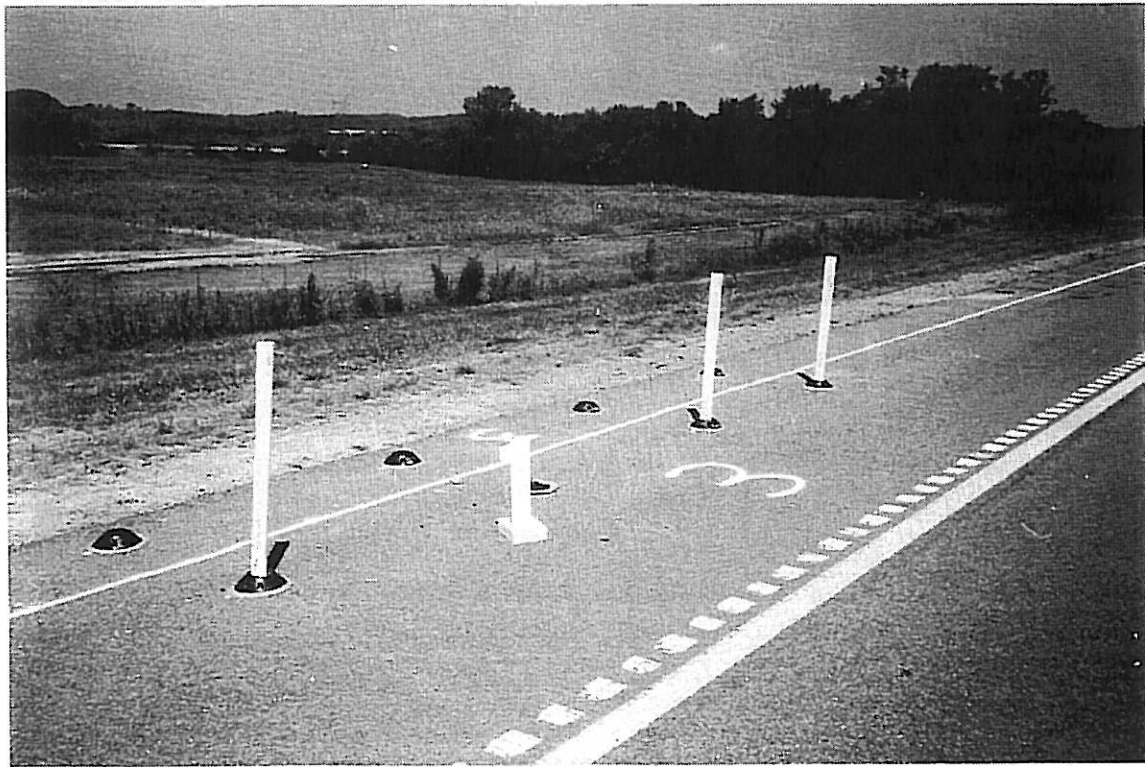
FIVE WINTER IMPACTS COMPLETED  
ONE SUMMER IMPACT COMPLETED

- #1 Impact: Post #1 and 2 could not be re-installed in the bases due to the severe tear at the bottom of the post.  
 Post #6 tore up at the bottom of the post.
- #2 Impact: No further damage noted.
- #3 Impact: Post #8 tore up at the bottom of the post.
- #4 Impact: No further damage noted.
- #5 Impact: No further damage noted.

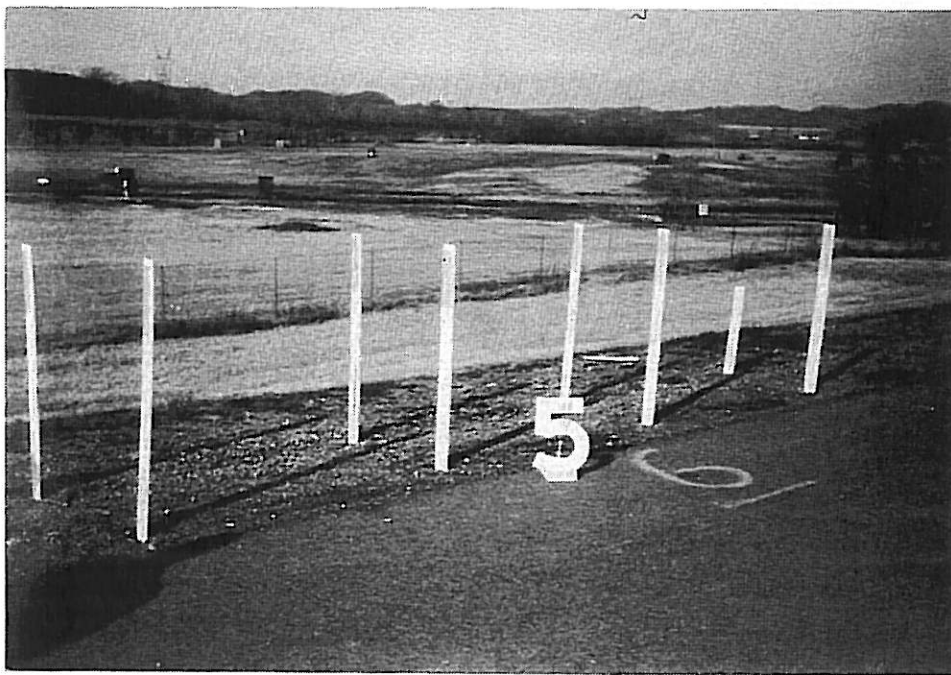
FIVE WINTER IMPACTS COMPLETED

#5 Impact: Post #4 tore in half.

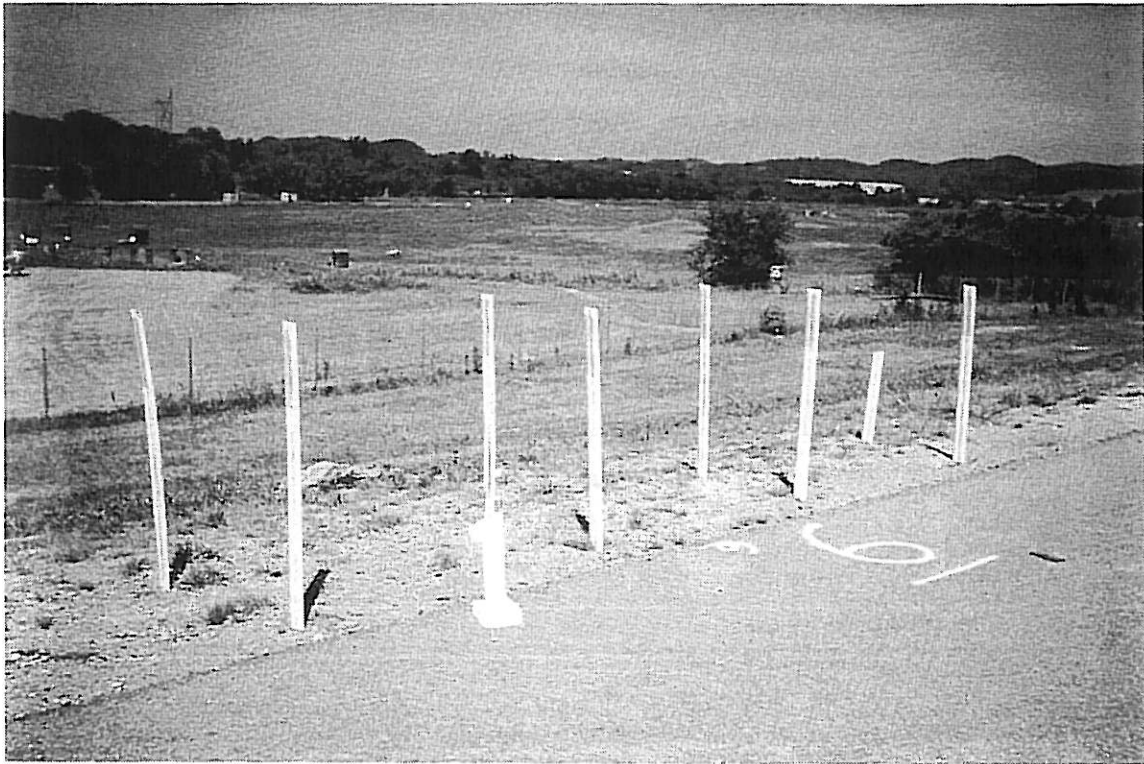
FIVE WINTER IMPACTS COMPLETED  
ONE SUMMER IMPACT COMPLETED

#1 Impact: Post #1 developed a 1 inch crack in the middle of the post.

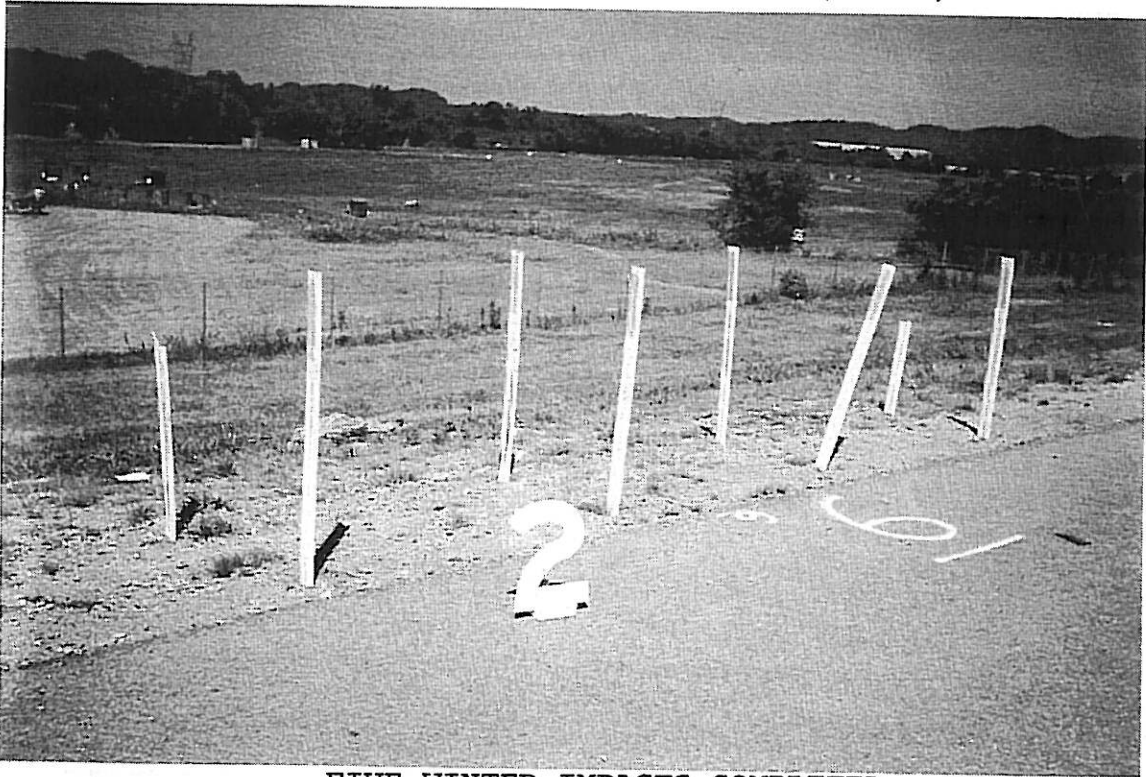
FIVE WINTER IMPACTS COMPLETED  
TWO SUMMER IMPACTS COMPLETED

#2 Impact: The top 12 inches of post #1 tore off. Post #5 had 10% sheeting damage.

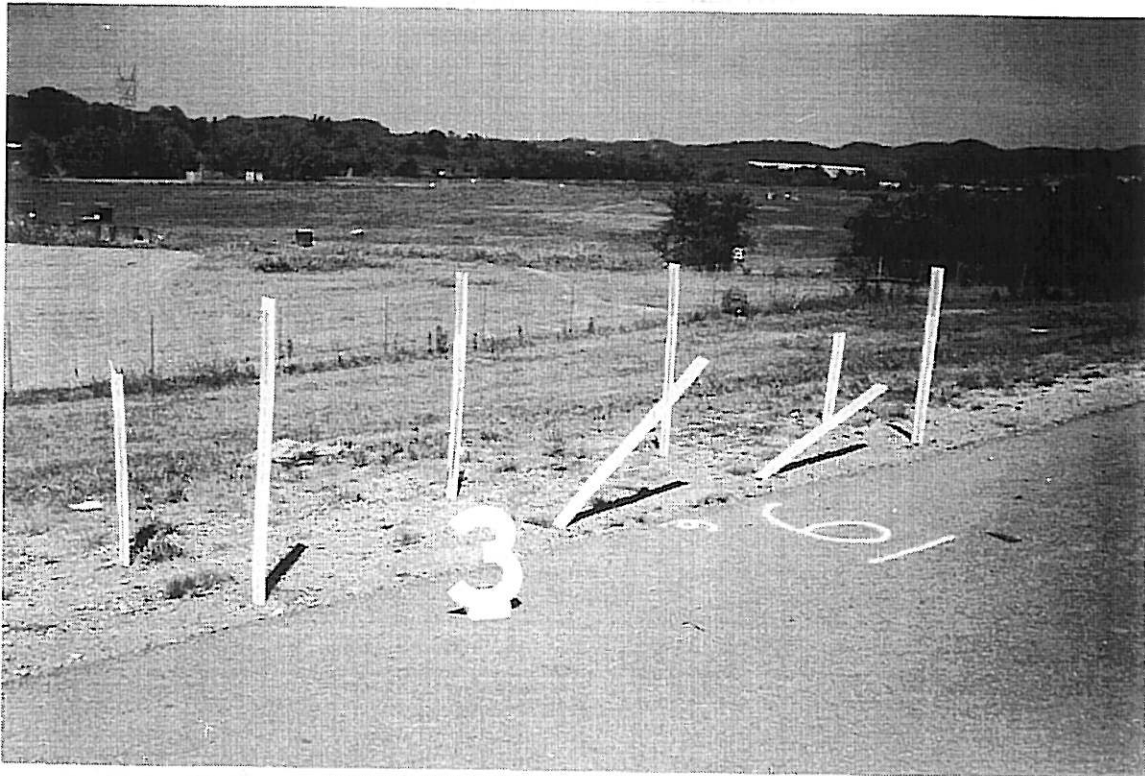
FIVE WINTER IMPACTS COMPLETED  
THREE SUMMER IMPACTS COMPLETED

#3 Impact: The bottom of post #6 and 7 developed a 1-1/2 inch crack.

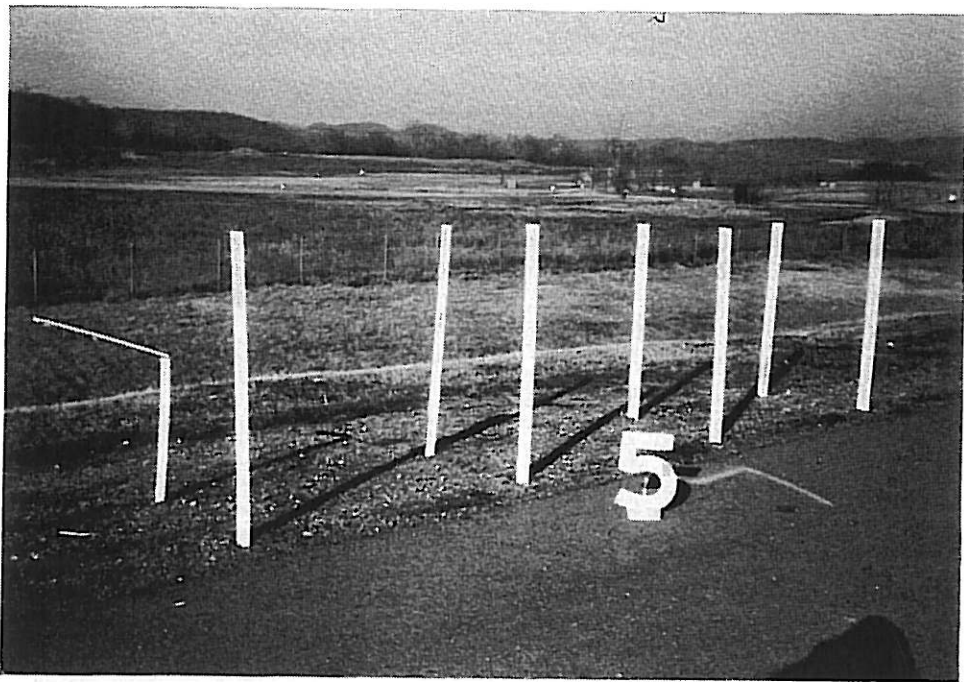
FIVE WINTER IMPACTS COMPLETED

#5 Impact: Post #1 cracked in the middle of the post and bent forward at an 80 degree angle.

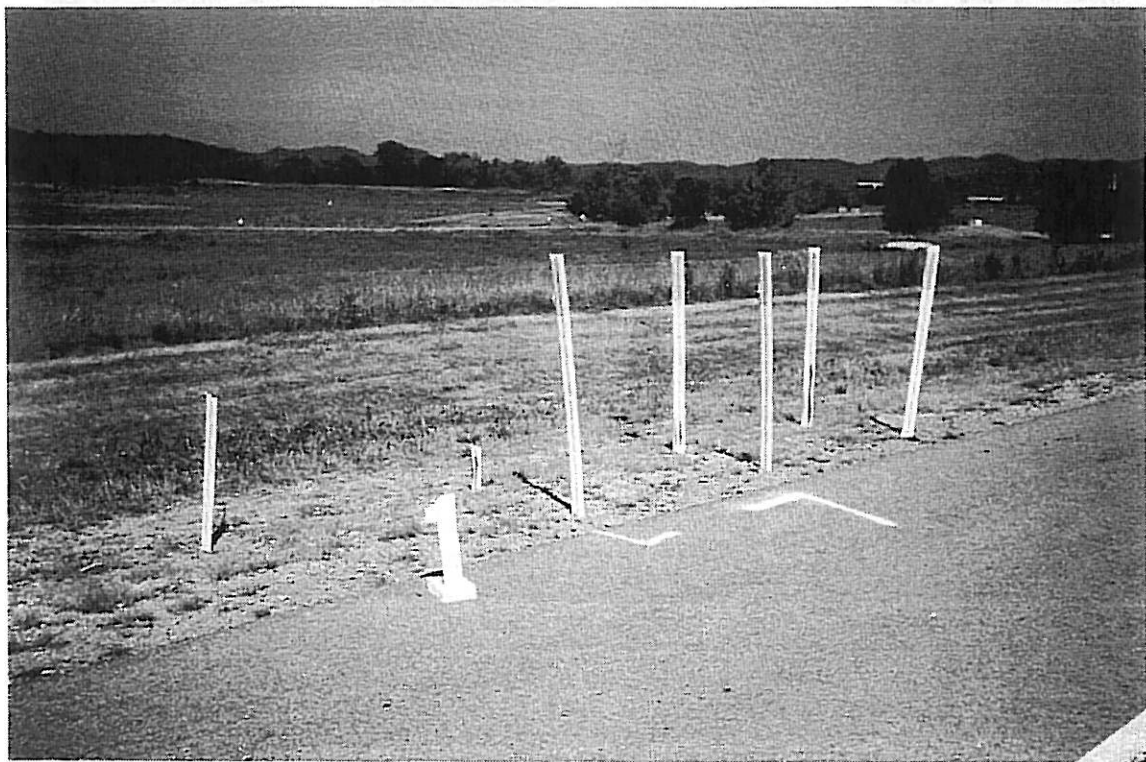
FIVE WINTER IMPACTS COMPLETED  
ONE SUMMER IMPACT COMPLETED

#1 Impact: Post #5 had been removed prior to summer testing. Post #2 tore off near the bottom of the post.

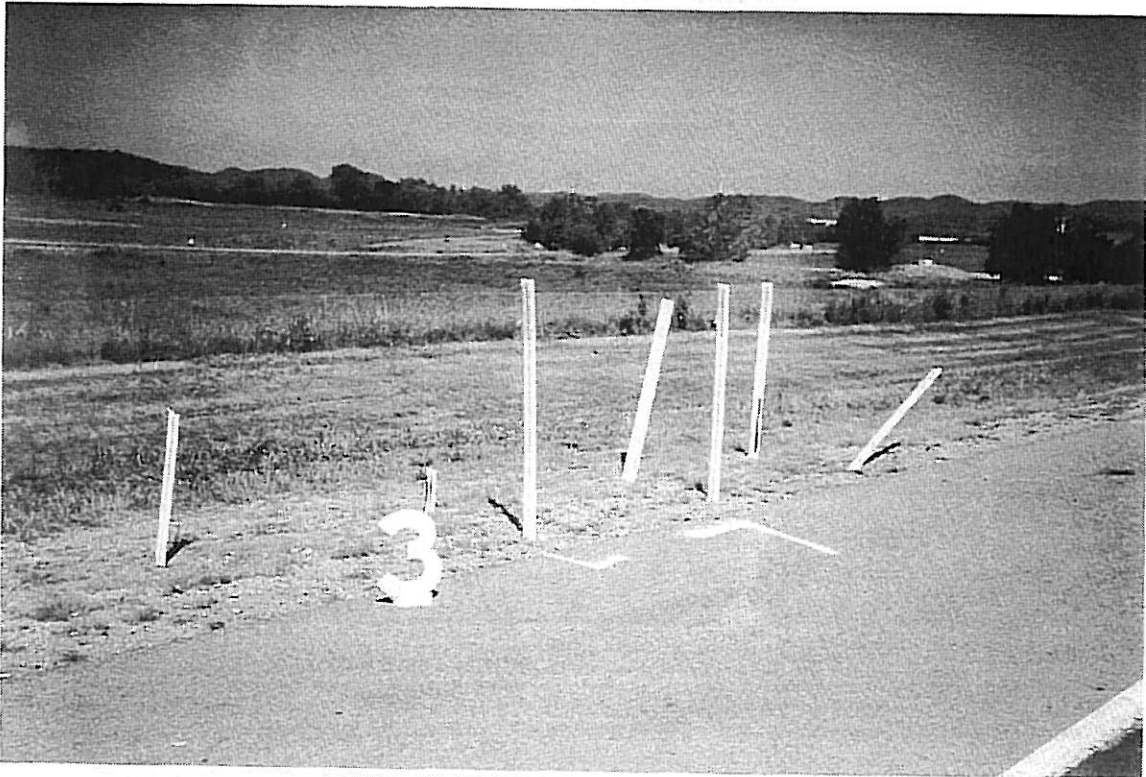
FIVE WINTER IMPACTS COMPLETED  
THREE SUMMER IMPACTS COMPLETED

#3 Impact: Post #8 developed a 2 inch crack near the bottom of the post and bent forward.

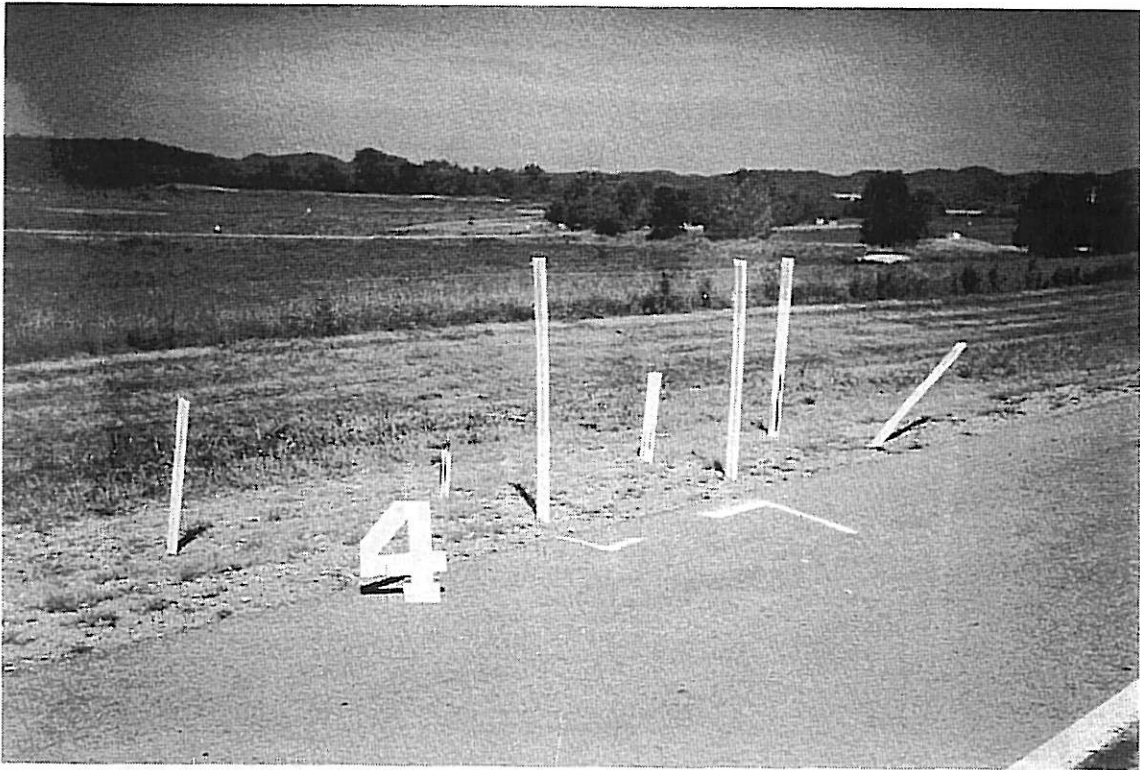
FIVE WINTER IMPACTS COMPLETED  
FOUR SUMMER IMPACTS COMPLETED

#4 Impact: Post #3 tore in half.
