Test Report No.: 690900-IRS B2
Test Report Date: December 2020

ASTM F3016-19 EVALUATION OF SLOWSTOP® BOLLARD

Contract No.: 2004494
Test Nos.: 690900-IRS B2
Test Date: 2020-10-26

Sponsored by
Impact Recovery Systems, Inc.®

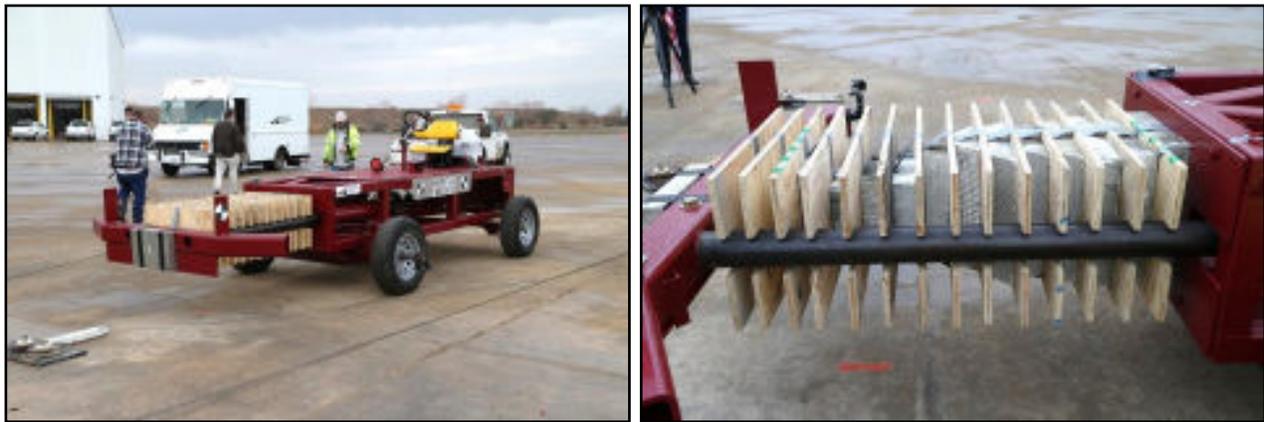
Figure 2.1. Test Vehicle prior to Testing.

The surrogate test vehicle, or bogie, is modeled after an American Association of State Highway and Transportation Officials (AASHTO) *MASH 2270P* pickup truck. This vehicle represents the 90th percentile in terms of vehicle weight for all passenger vehicles sold in 2002. The surrogate test vehicle shown in Figures 2.1 was used for each crash test. Gross static weight of the vehicle was 4980 lb. The height to the lower edge of the vehicle front bumper was 17.25 inches, and the height to the upper edge of the front bumper was 29.25 inches. The height of the center of gravity was 28.0 inches. Appendix B gives additional dimensions and information on the vehicle. The vehicle was directed into each installation using a reverse-pull cable system and guidance cable. The vehicle was released and was unrestrained and free-wheeling 10 ft prior to impact.

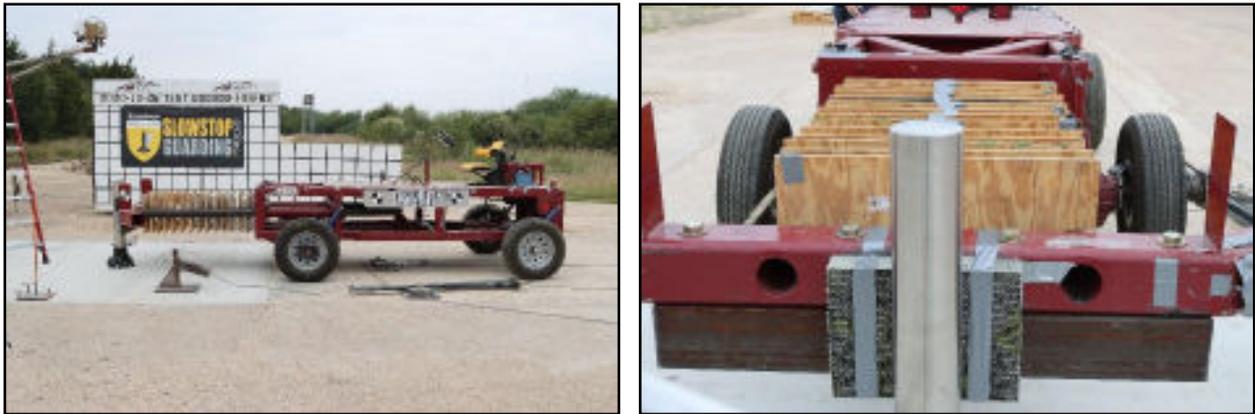
Figure 4.1. Bogie and Installation Geometrics for Test No. 690900-IRS B2.

ASTM F3016-19 Test S10 was performed on the SlowStop® Bollard. Target speed was between 9.0 and 18.9 mi/h at an impact angle of 90 degrees, and target impact height of 28 inches. Actual impact speed was 10.4 mi/h and actual impact angle was 90.5 degrees, and impact height was 28.2 inches. Target and actual impact point was the centerline of the bogie aligned with the centerline of the bollard.

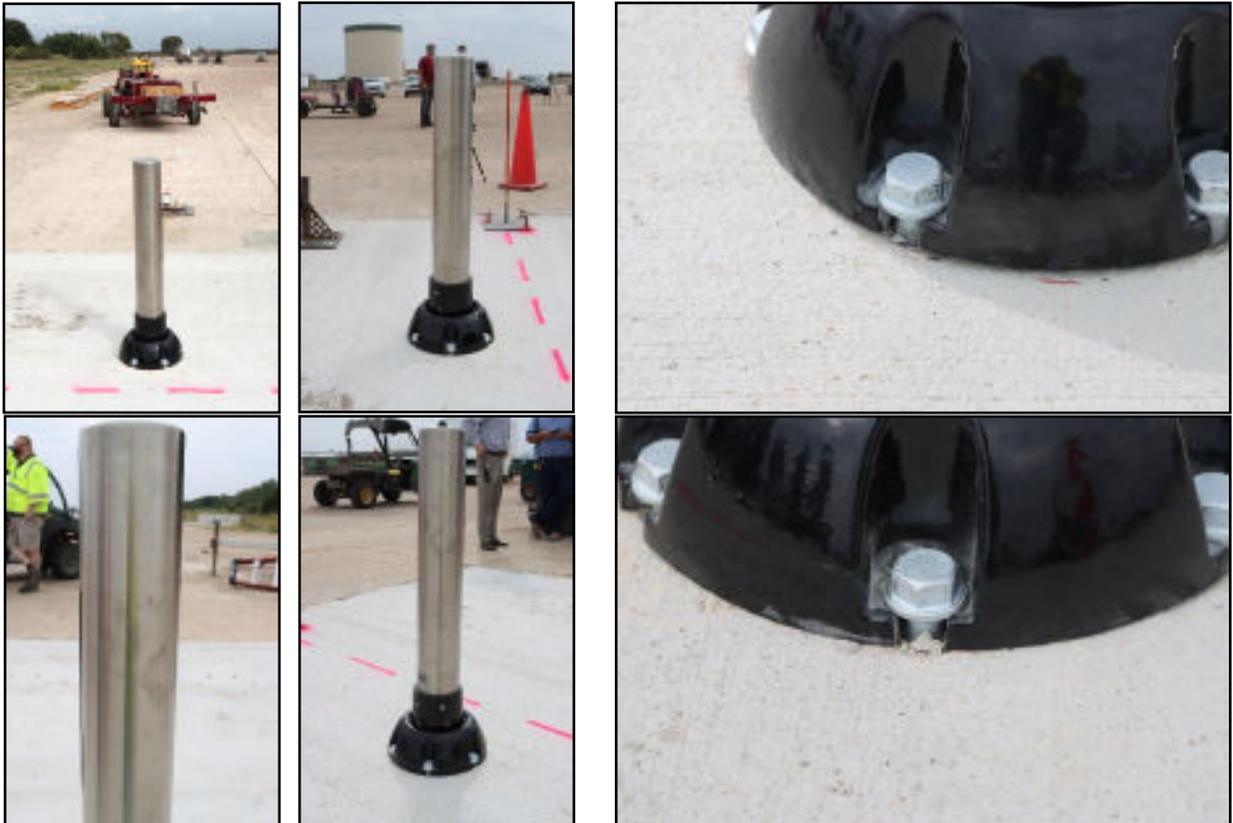
Figure 4.2. Installation after Test No. 690900-IRS B2.

Figure 4.2 shows the damage to the bollard. The lean angle of the bollard was initially 89.5 degrees from horizontal to the protected side, and after the test, the bollard was 88.7 degrees from horizontal. Maximum dynamic deflection of the bollard during the test was 12.6 inches toward the protected side measured at the top of the bollard. The base of the bollard at grade showed only slight movement toward the protected side. The foundation around the base of the bollard was not cracked or spalled.

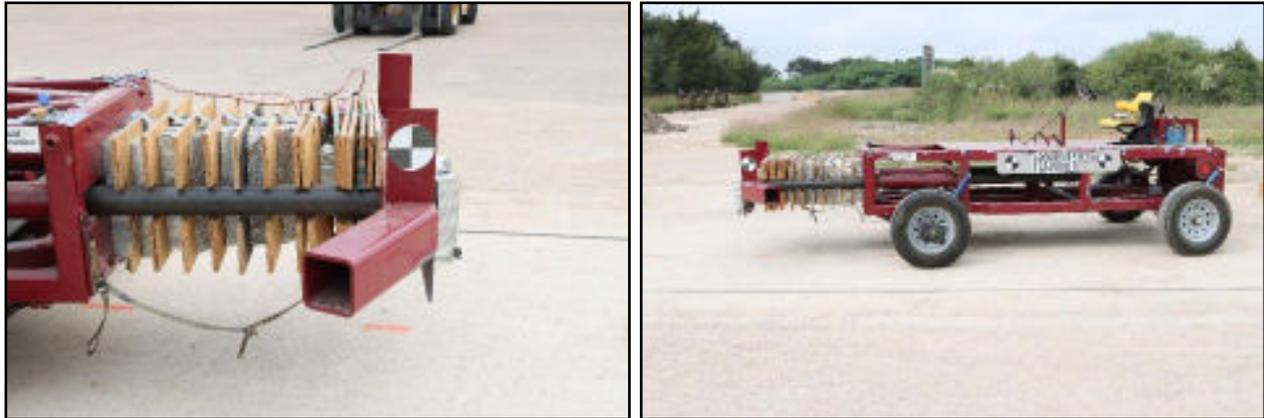
Figure 4.3. Vehicle after Test No. 690900-IRS B2.

Damage to the vehicle is shown in Figure 4.3. Table 4.2 provides the honeycomb compression on the bogie. The initial overall length of the bogie's nose was 59.75 inches, and after impact it was 42.5 inches. Total crush of the honeycomb nose of the surrogate test vehicle was 17.25 inches. The maximum penetration of the vehicle was 9.8 inches, and it rebounded to 31.5 ft in front of the bollard. No debris from either the surrogate test vehicle or the test installation penetrated into the protected area.

Table 4.2. Deformation of Honeycomb Nose after Test No. 690900-IRS B2.

Honeycomb Position	Thickness Before (inches)	Thickness After (inches)
1	3.25	3.00 top – 0.75 bottom
2	2.50	0.13
3	2.25	0.13
4	2.25	0.25
5	2.38	0.38
6	3.25	0.50
7	3.13	1.00
8	3.13	1.50
9	3.25	1.50
10	3.00	3.00
11	3.00	3.00
12	3.00	3.00
13	3.13	3.13
14	3.13	3.13
15	3.00	3.00
16	3.00	3.00

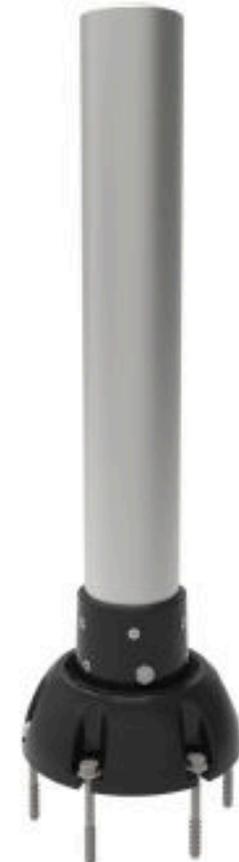
Figure 2

1. Layout and mark final location using the base as a guide. Remove base. *Note: Keep the bollard 0.32 x height away from any solid object to allow for tilting.*
2. Place the elastomer in the center of the location and place adapter on top of elastomer.
3. Fit base over the adapter so that it rests on the adapter flange and covers the elastomer.
4. Again using the base as a guide, drill six holes at least 5-1/2" deep. Clean out the holes from concrete dust.
5. Tighten the concrete screw Anchors in a star pattern, compressing the elastomer and making the base flush to the concrete. Anchor head must be tightened flush to base.
6. Insert the tube into the adapter and align the pipe hole with one screw hole. Insert and tighten the 40mm hex screw through the adapter and that hole. Firmly tighten the rest of the set-screws.
7. When complete, the assembly should appear like Figure 2.

Note: Do not concrete fill the bollard. The system is designed for the pipe to be the first point of bending

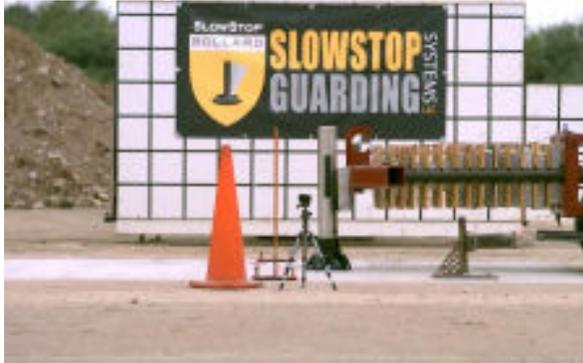
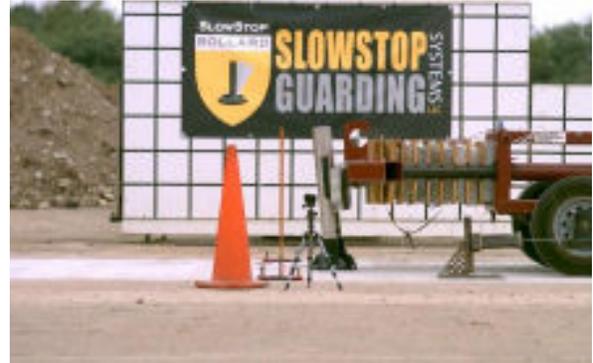
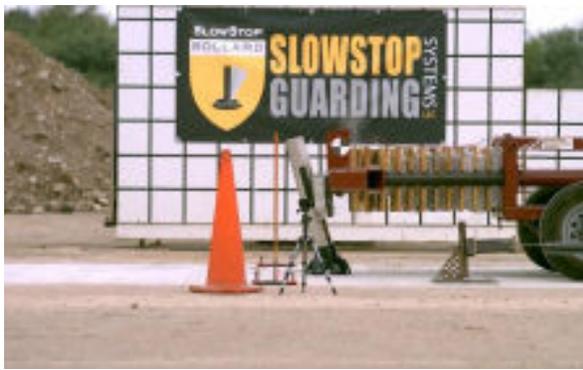
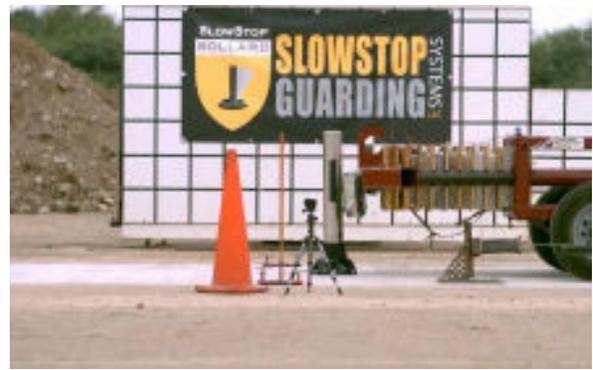
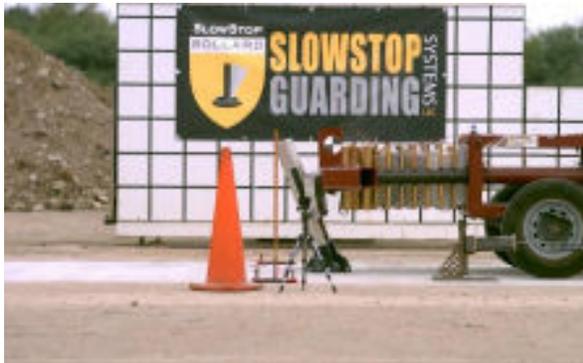
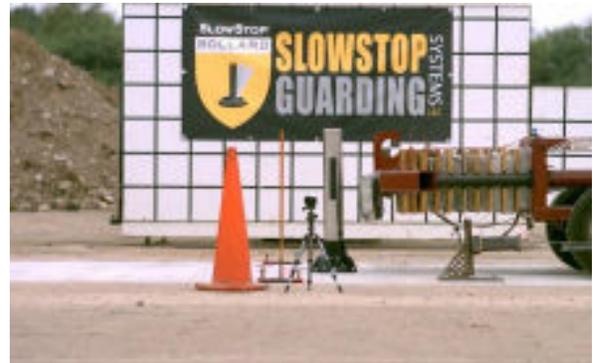
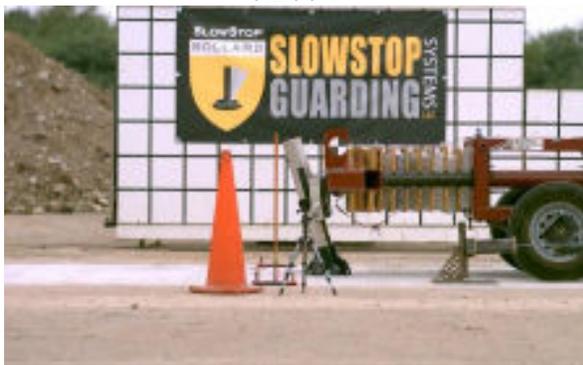
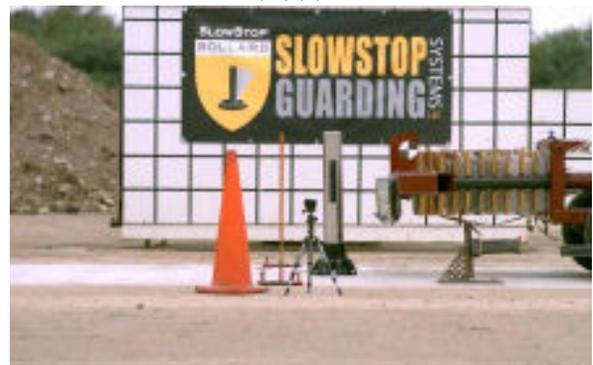
Figure F.1. Sequential Photographs for Test No. 690900-IRS B2 (Perpendicular View).

The surrogate vehicle was traveling at an impact speed of 10.4 mi/h when it impacted the bollard at an impact angle of 90.5 degrees. Table 4.1 lists events that occurred during Test No. 690900-IRS B2. Figure F.1 and F.2 in Appendix F.1 shows sequential photographs of the test period.

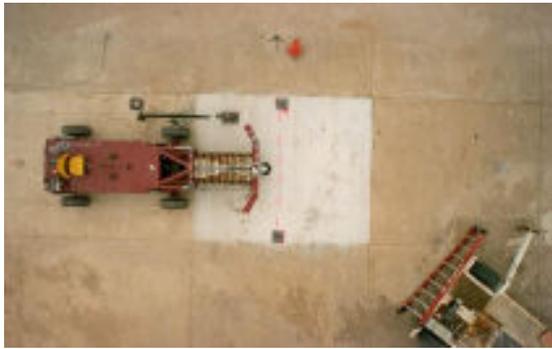
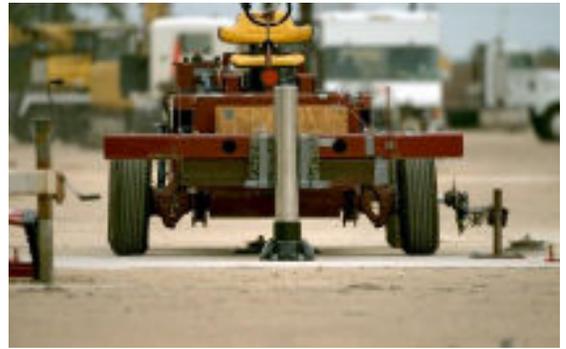
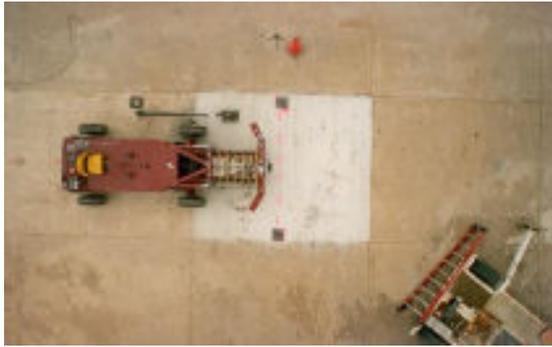
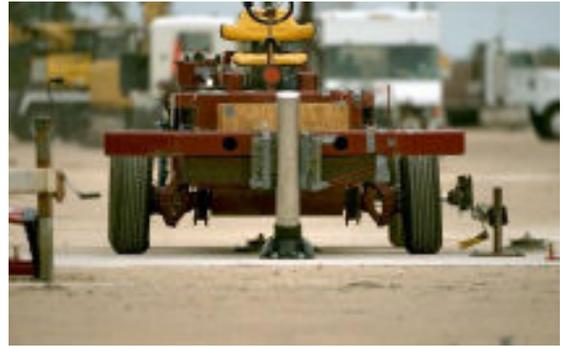
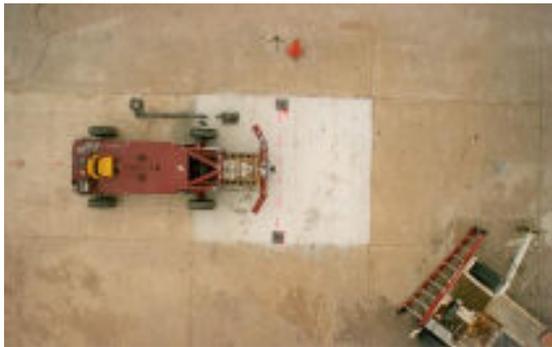
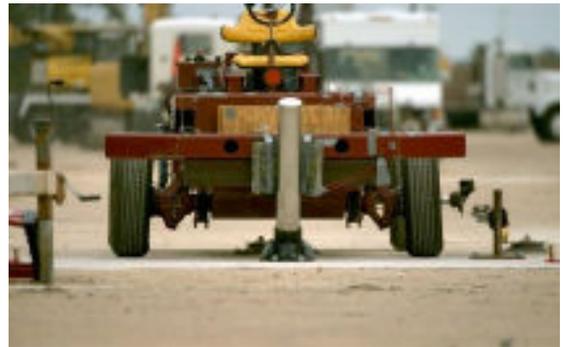
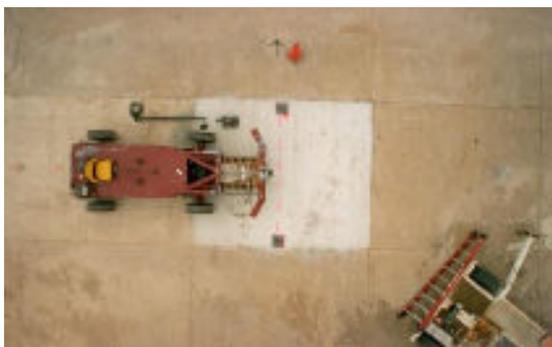
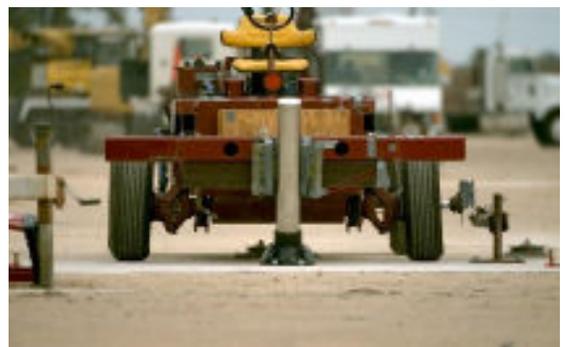
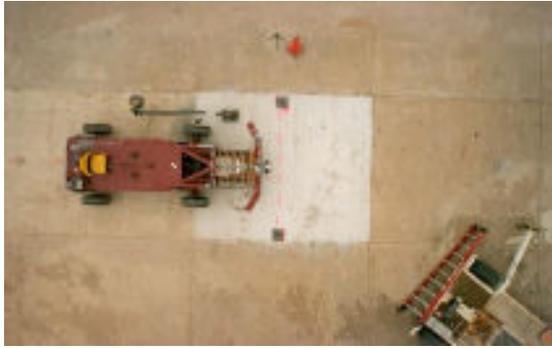
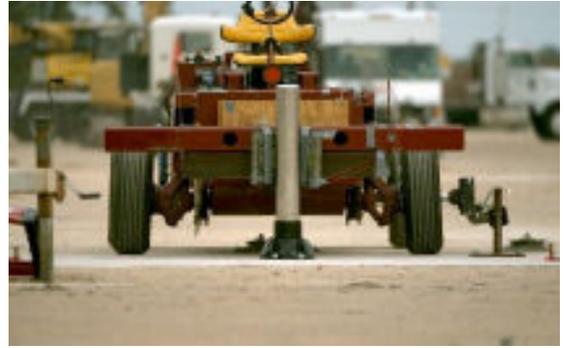
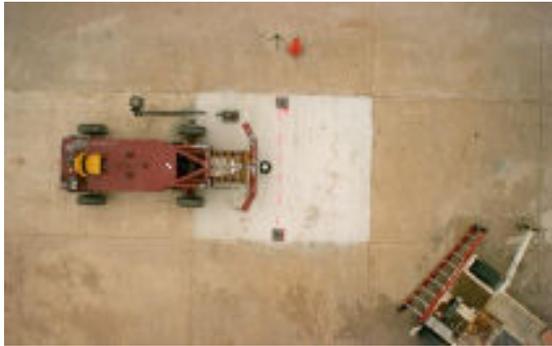
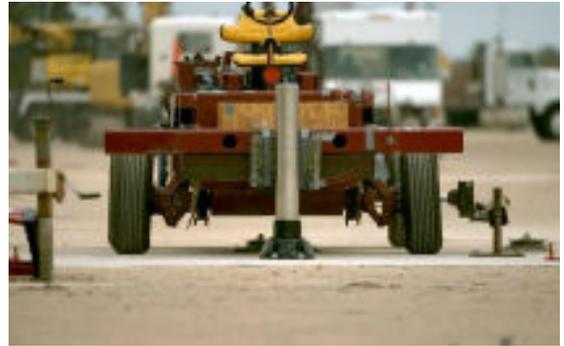
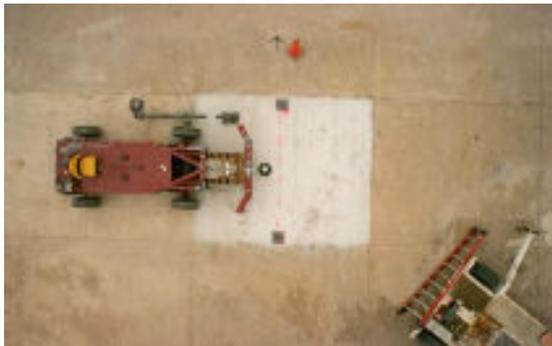
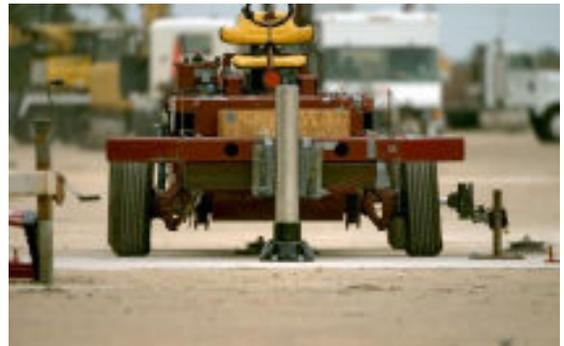
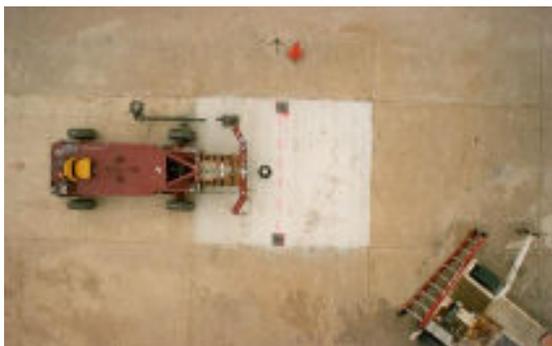
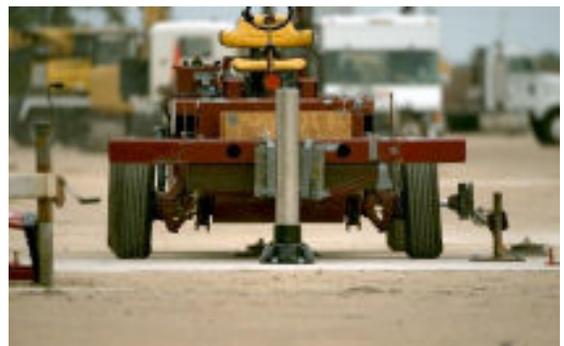
**Figure F.2. Sequential Photographs for Test No. 690900-IRS B2
(Overhead and Frontal Views).**

- One overhead with a field of view perpendicular to the ground and directly over the impact point;
- One placed to have a field of view parallel to and aligned with the installation at the downstream end; and
- A third placed to have a field of view perpendicular to impact path and aligned with the P1 distance line.
