# Certified Test Report

## Object Marker High Visibility Median Separator

December 18, 2007

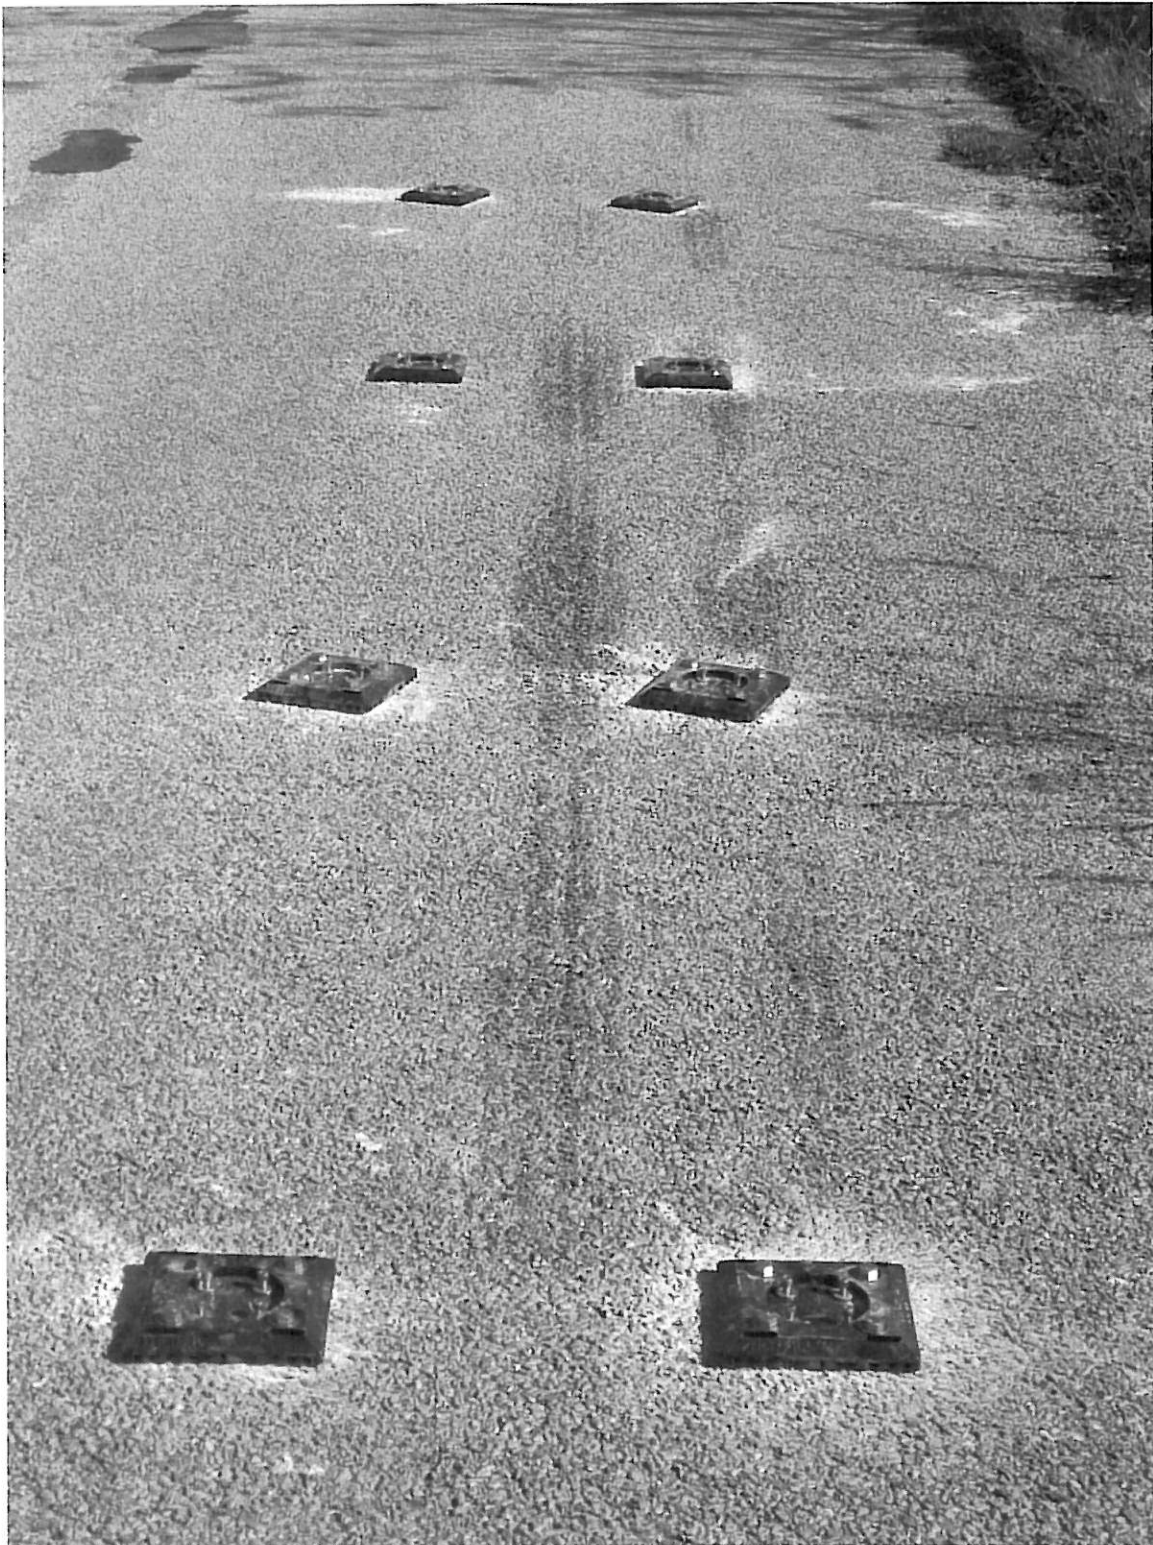
Photo #1  
#101 Fixed Bases, installed, depicting the second and fourth row of  
bases installed at a 25 degree slant.

Impact Recovery Systems' Object Markers consist of polyethylene post and polyethylene panel sheeted with 3M Yellow Hi Intensity sheeting mounted on a polyethylene base. The bases were held down with an anchor kit consisting of (4) 4" lag screws, (4) washers, and (4) plastic sleeves. Installation time averaged 1-1 ½ minutes per post. Four of the eight bases were installed straight forward while the remaining bases were installed at a 25 degree slant.

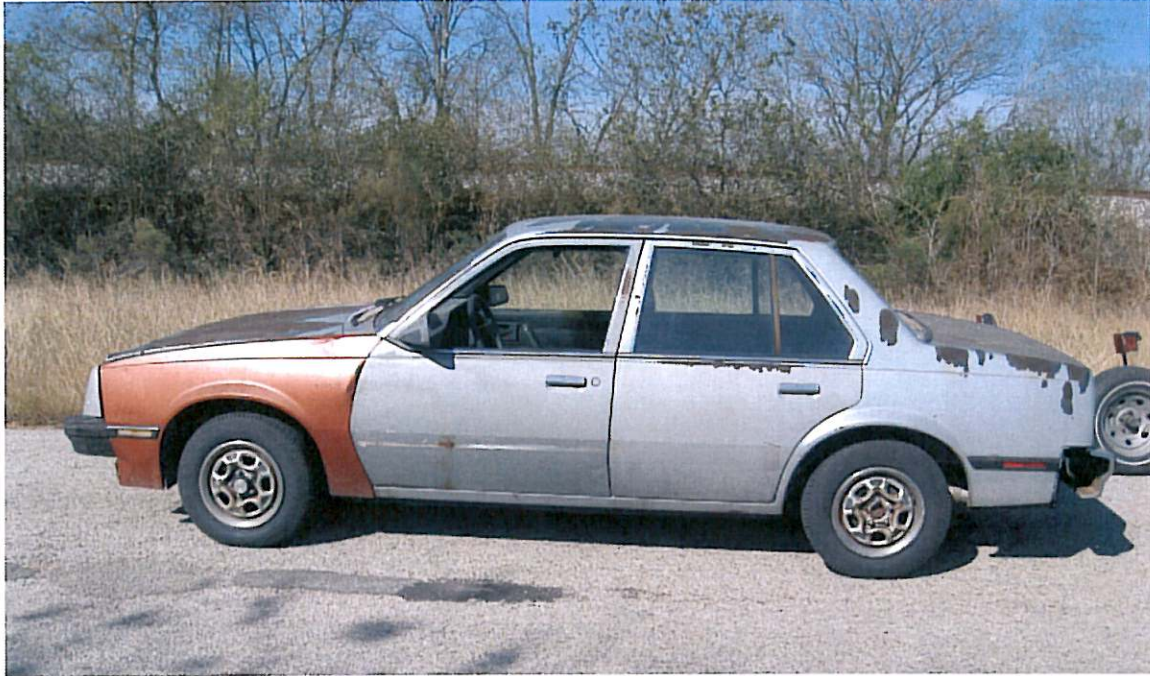
Photo #2  
1985 Chevrolet Cavalier used for impact testing.

The impact vehicle used in the testing was a 1985 Chevy Cavalier. No alterations were made to the vehicle.

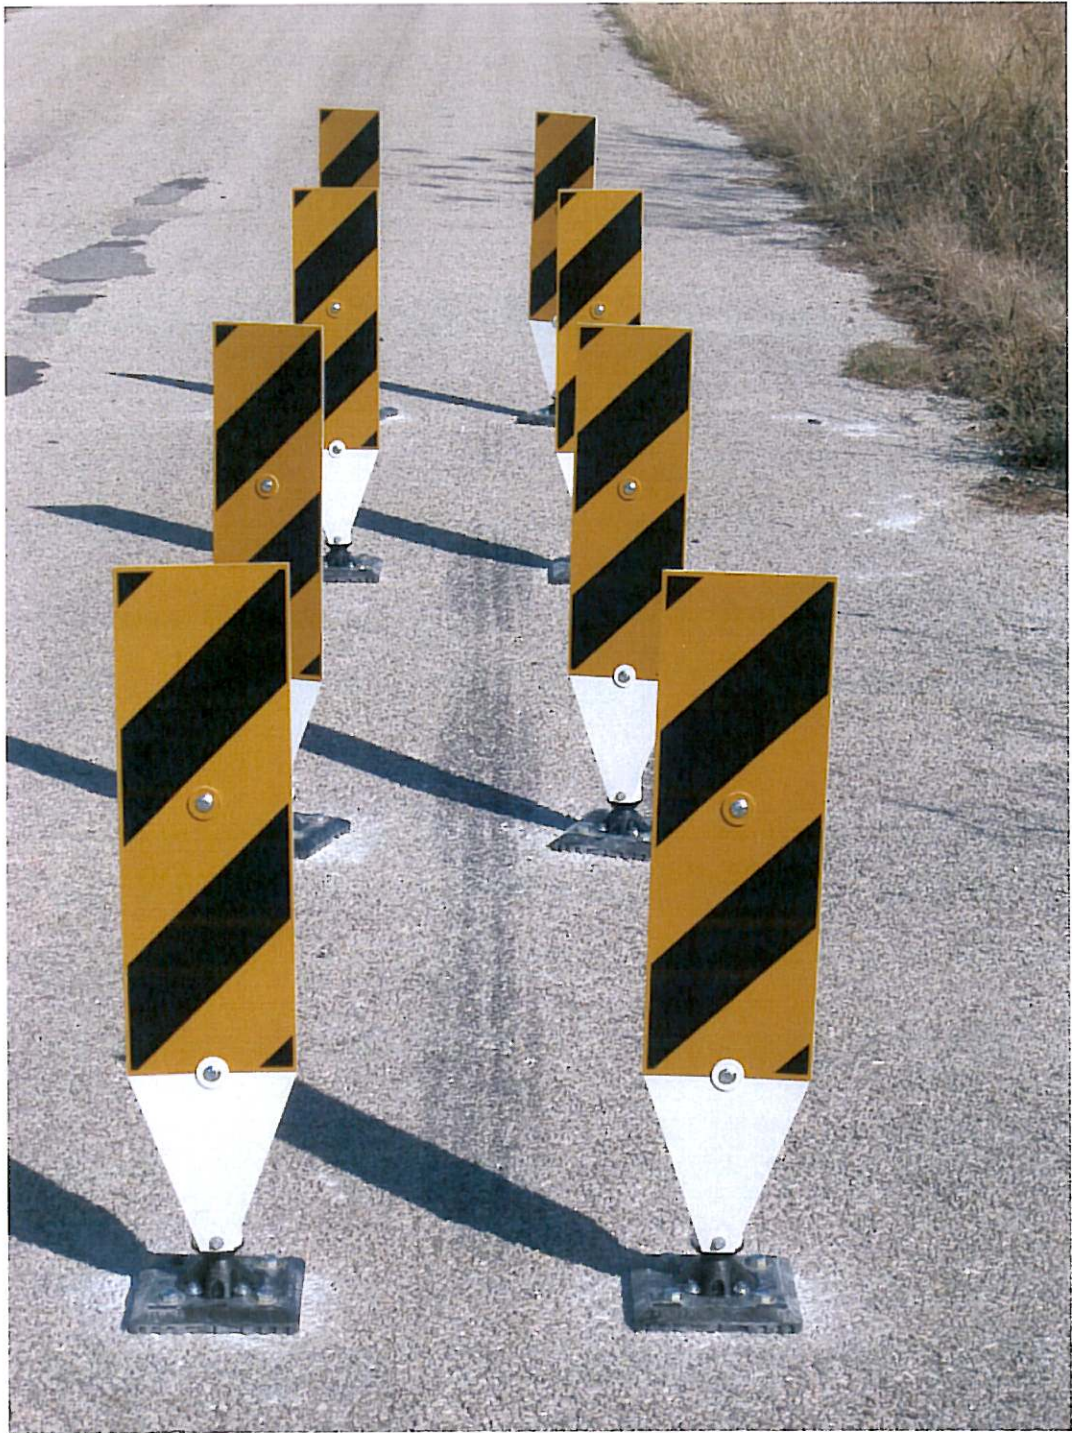
Photo #3  
Object Markers installed, no impacts.

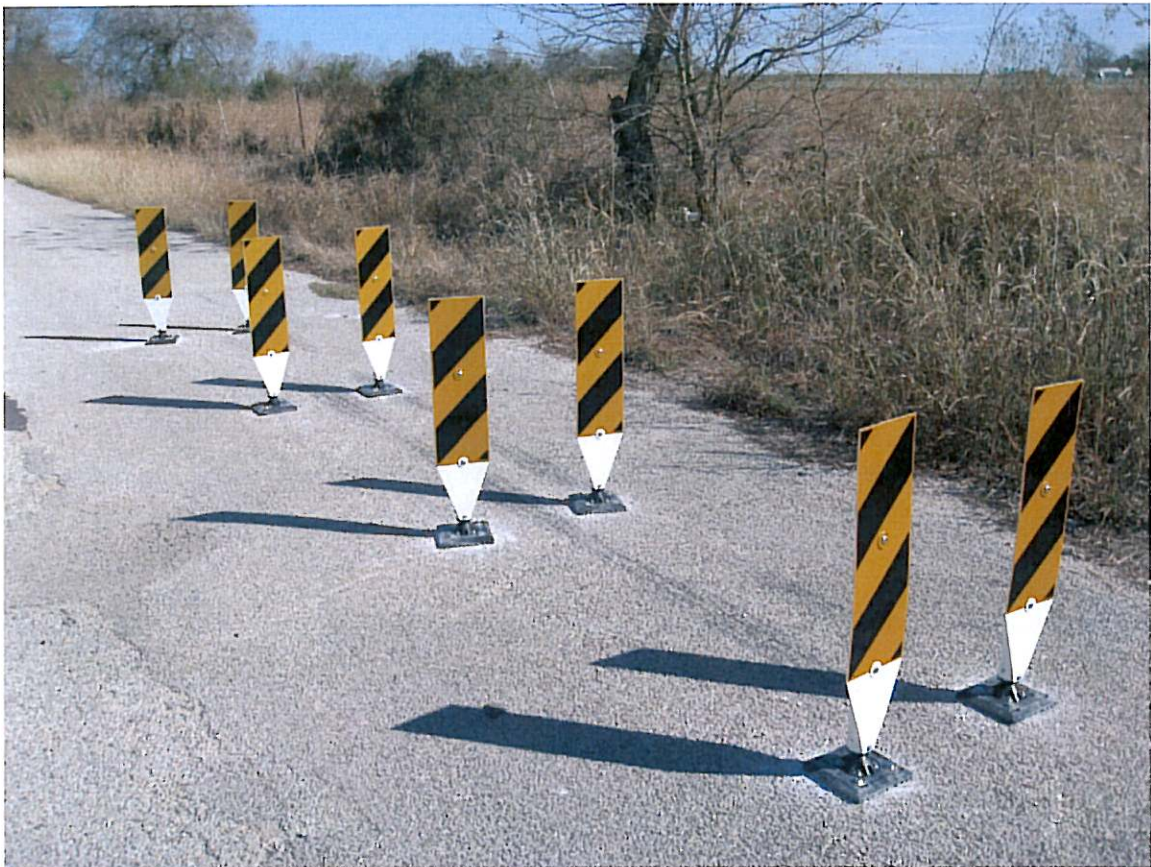
Photo #4  
Object Markers installed, no impacts.

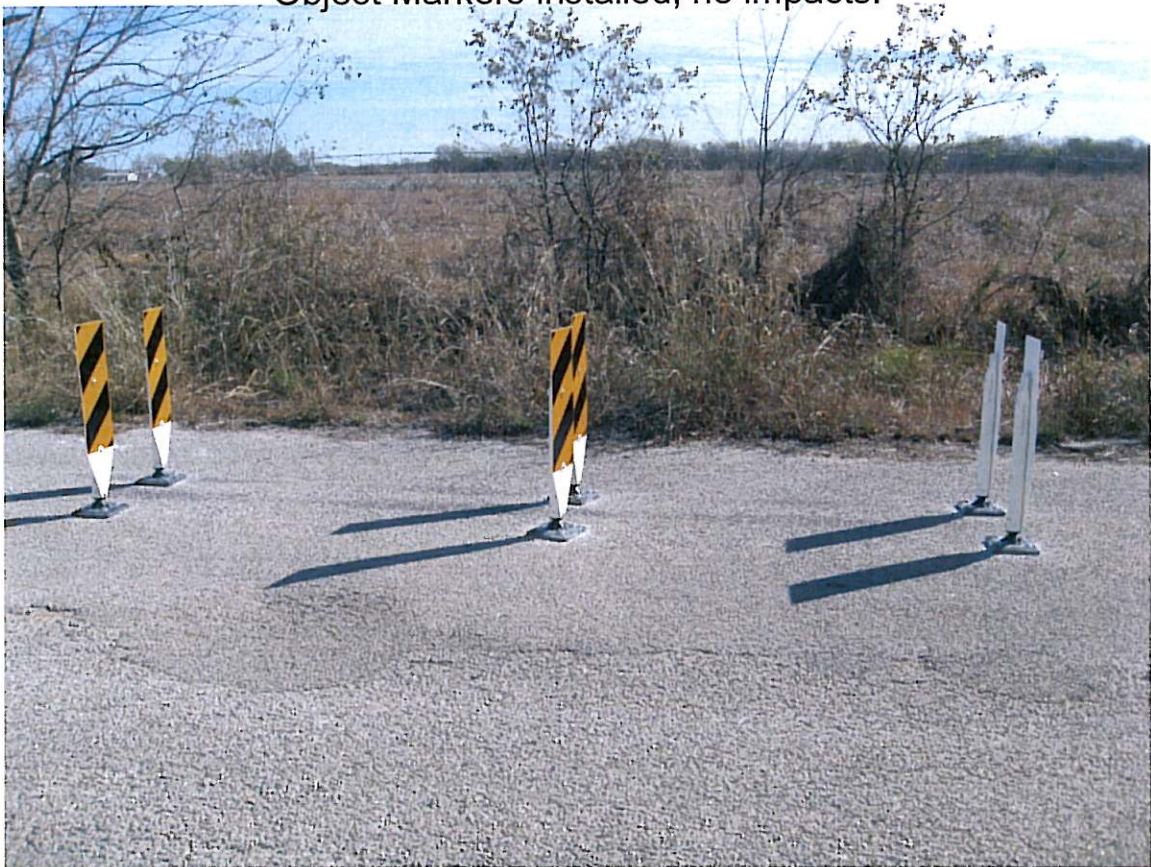
Photo #5  
Object Markers installed, no impacts.

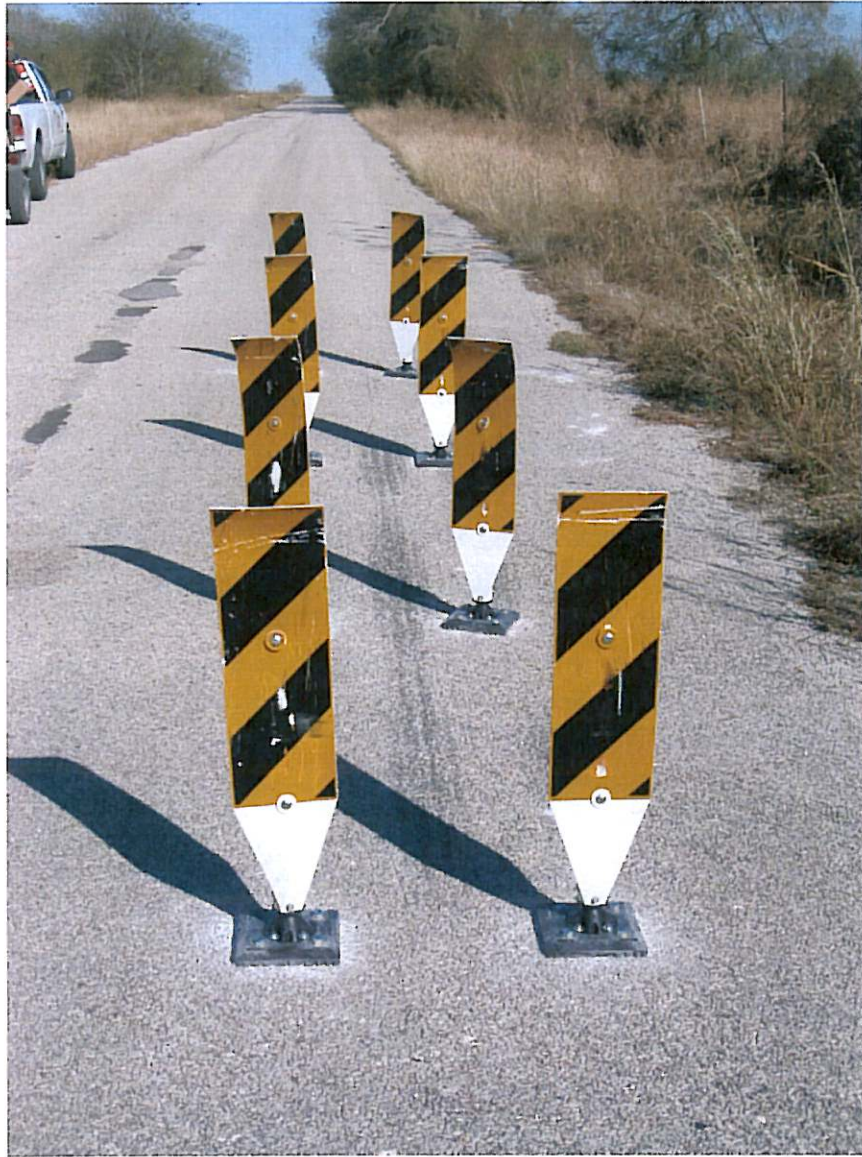
Photo #6  
5 impacts completed. 8 Object Markers remaining. 95% of sheeting  
remains intact. No listing.

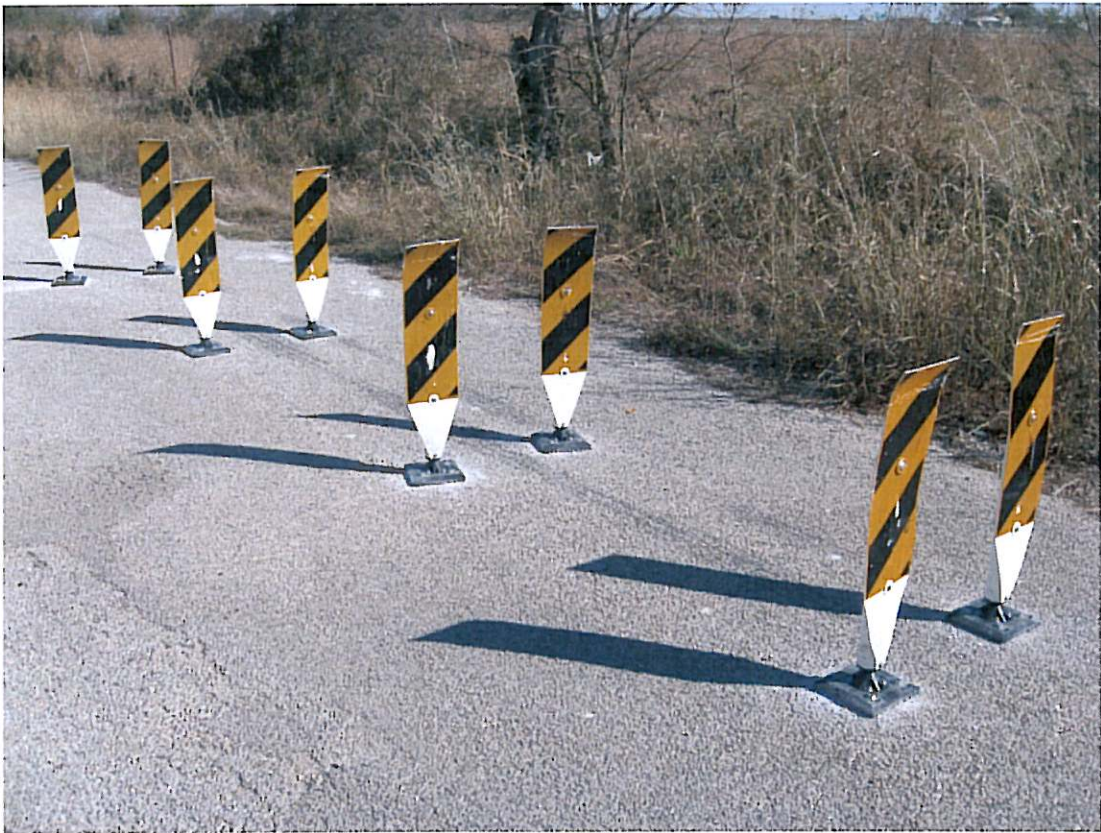
Photo #7

5 impacts completed. 8 Object Markers remaining. 95% of sheeting remains intact. No listing.

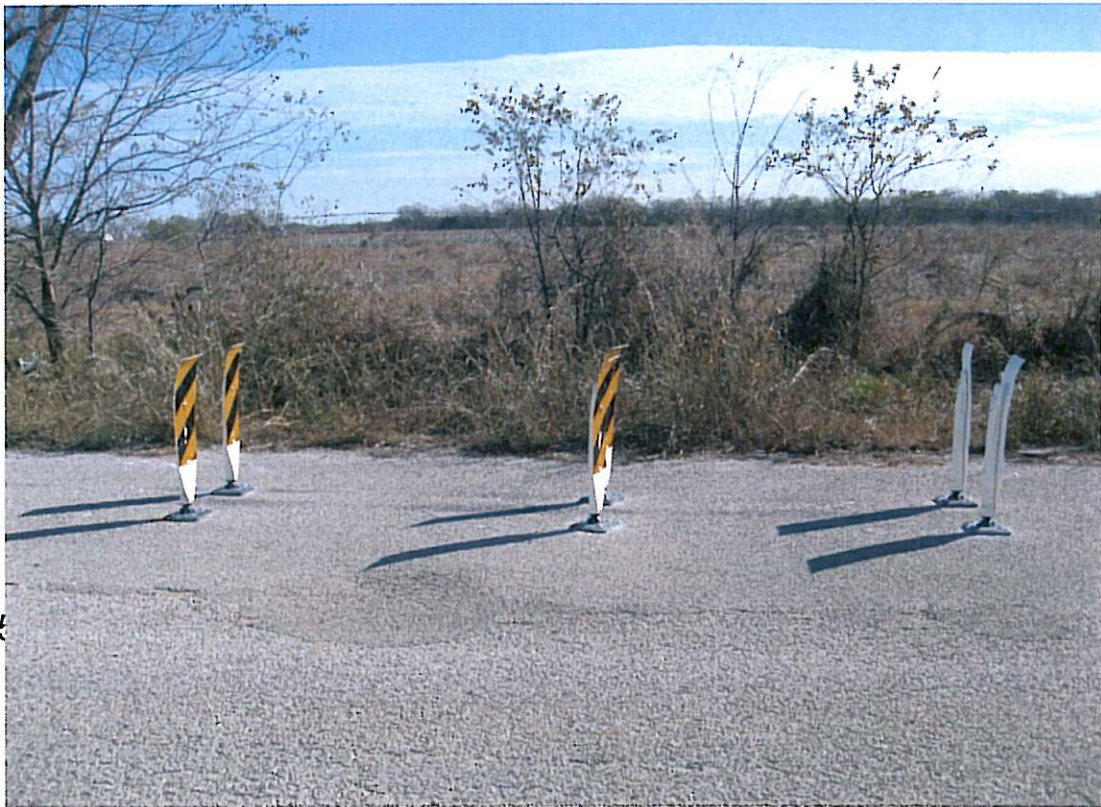
Photo #8

5 impacts completed. 8 Object Markers remaining. 95% of sheeting remains intact. No listing.

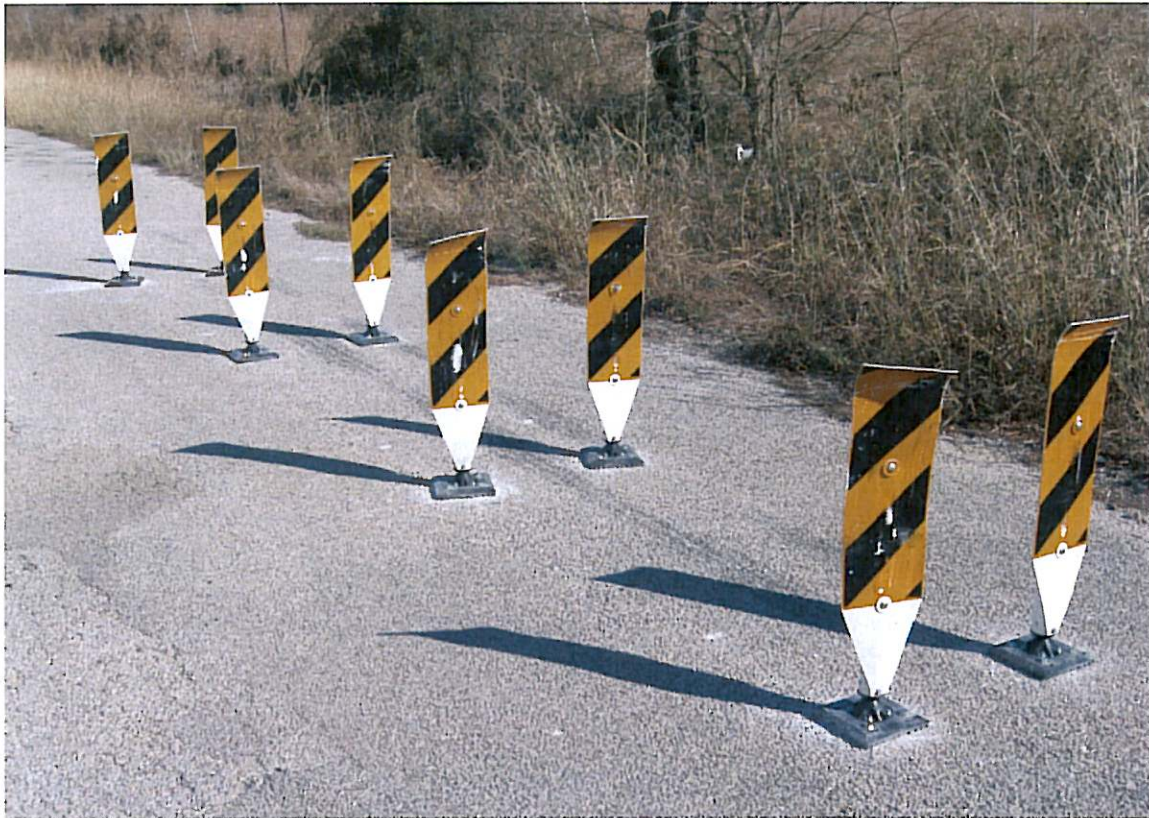
Photo #9

10 impacts completed. 8 Object Markers remaining. 95% of sheeting remains intact. No listing.

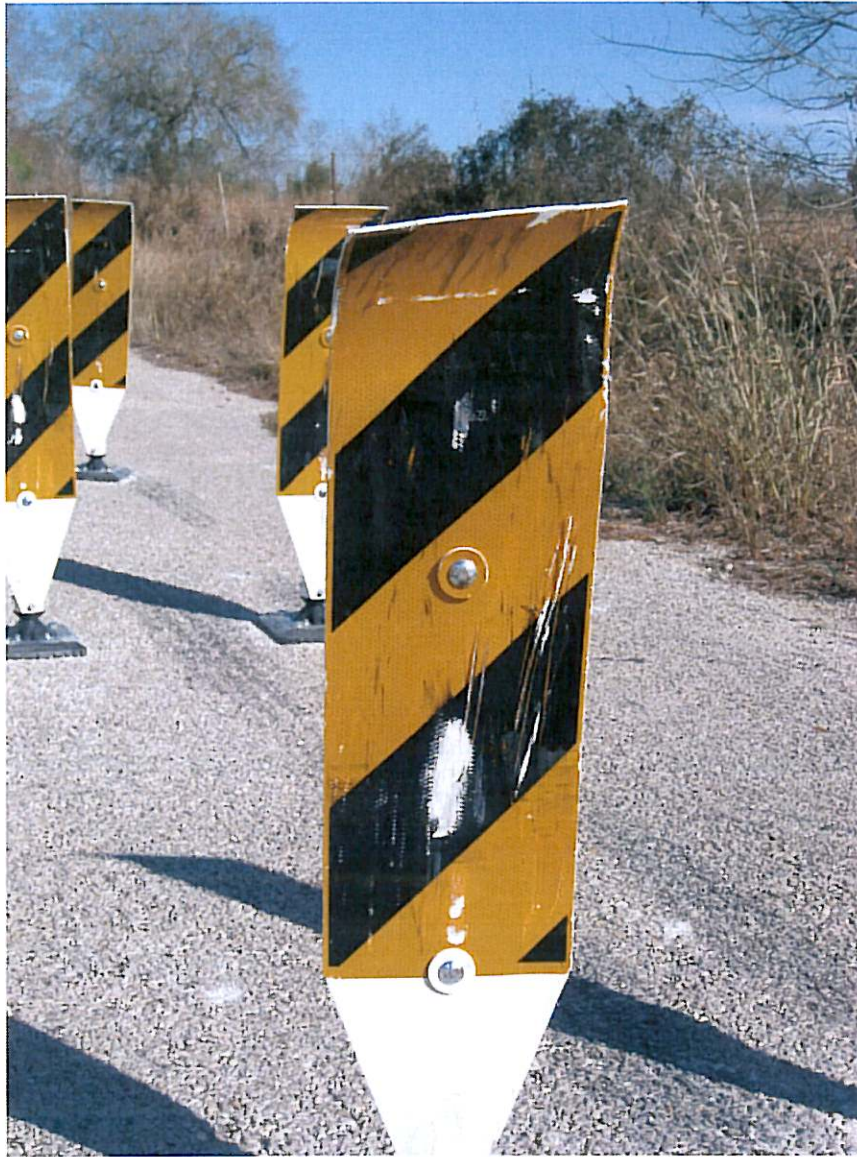
Photo #10

10 impacts completed. 8 Object Markers remaining. 95% of sheeting remains intact. No listing.

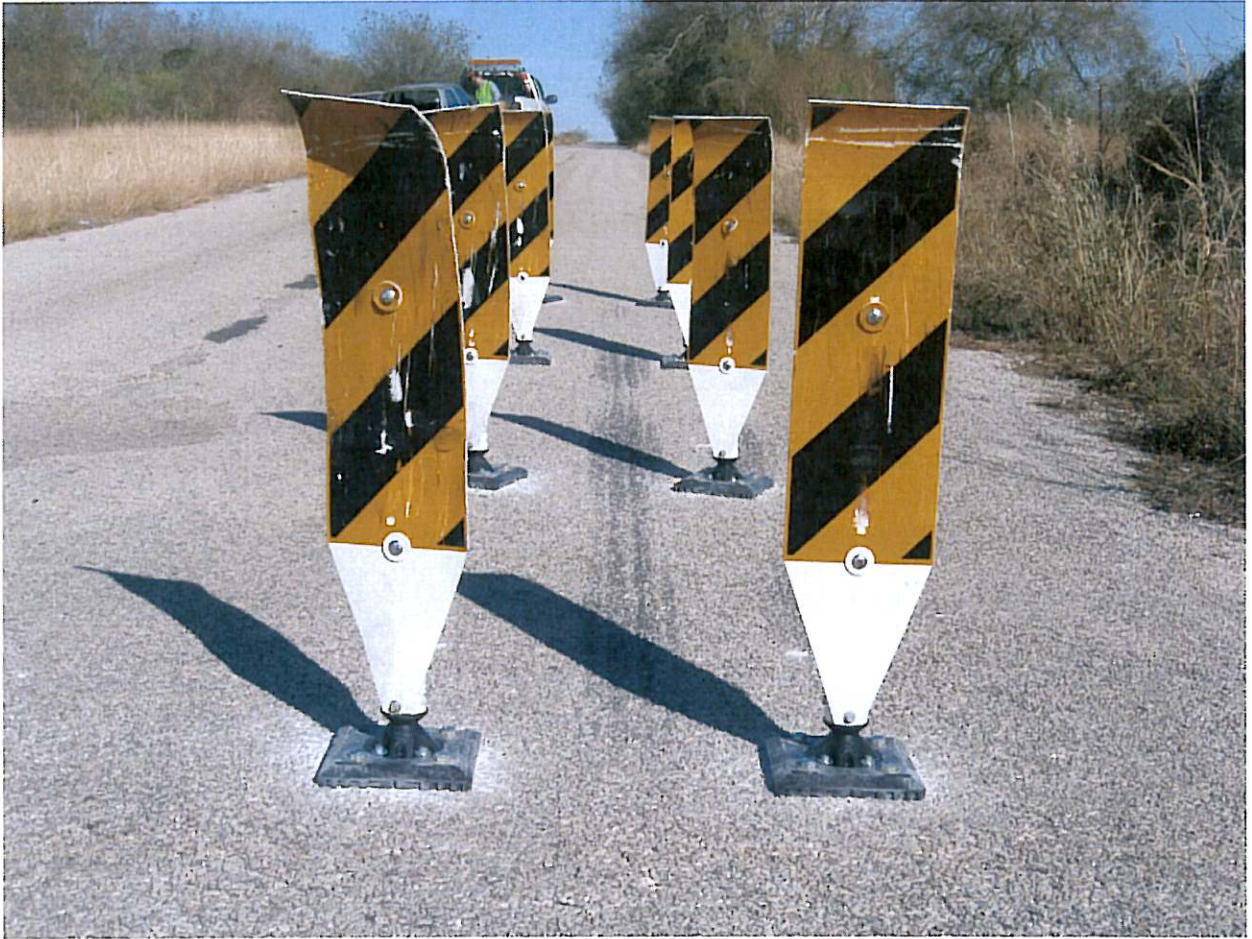
Photo #11

10 impacts completed. 8 Object Markers remaining. 95% of sheeting remains intact. No listing.

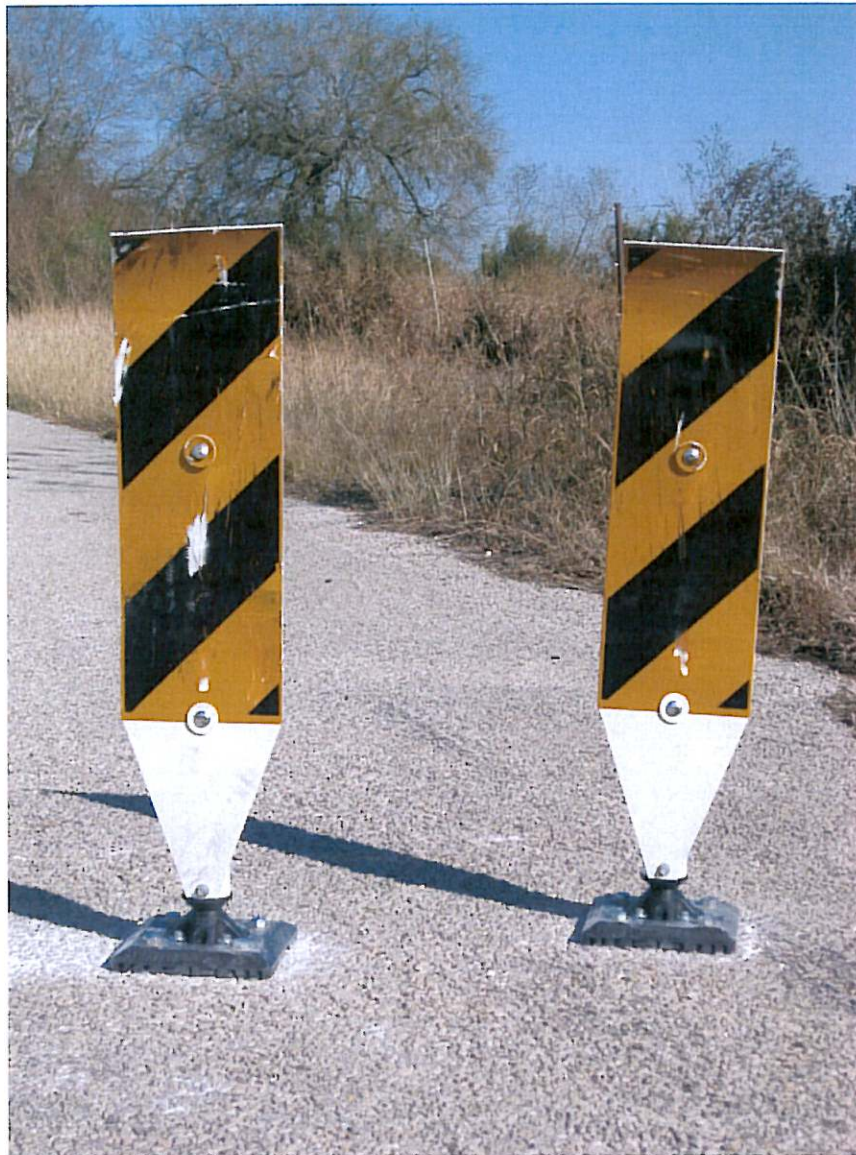
Photo #12  
10 impacts completed. 8 Object Markers remaining. 95% of sheeting  
remains intact. No listing.
