TECHNICAL MEMORANDUM

Contract No.: P2011067
Report No.: 400001-IRS6
Project Name: Impact Testing to MASH Standard for Tuff Curb and Tuff Curb XLP
Sponsor: Impact Recovery Systems, Inc.

DATE: March 14, 2011

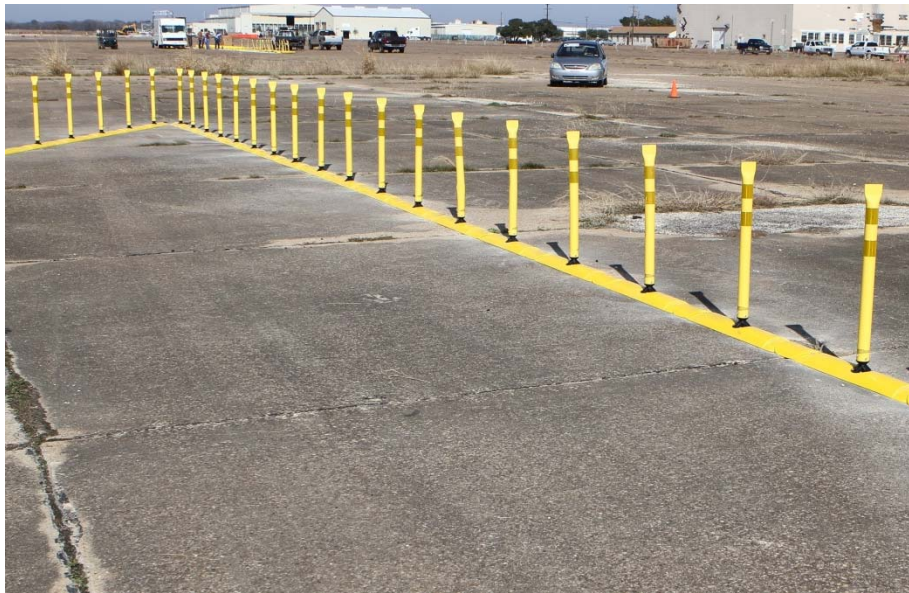
Figure 1 shows a typical test setup for the curb installations tested. Further details of the Tuff Curb and Tuff Curb XLP are presented in Attachment A, along with the various maneuvers in which they were tested.

Figure 1. Typical setup.

Tests IRS6-1 through IRS6-8 were performed on a Tuff Curb installation. The Tuff Curb segments were constructed of High Density Polyethylene. Each curb segment was 40 inches long by 12 inches wide and 3.5 inches tall. Each curb segment is constructed of two smaller sections. The sections were joined at the mid-length of the curb segment. The curb was attached to the roadway surface at two bolting locations at either end of the segment. The test installation utilized two ½-inch wedge bolts to anchor each curb section. The test installation was constructed in a 30-degree "V" formation. The longer leg of the "V" was constructed using 40

sections with no gap between segments and with 18-inch long end caps placed at each end (136 ft-4 inches). The shorter leg of the “V” was constructed using 10 segments with no gap between segments and with 18-inch long end caps placed at each end (36 ft-4 inches). A single 36-inch delineator (Model: TP36FQR) with single quick release pin was installed in each segment location. For further details see detail drawings in Attachment A.

Tests IRS6-9 through IRS6-16 were performed on the Tuff Curb XLP with coupler. The Tuff Curb XLP segments were constructed of High Density Polyethylene. Each curb segment was 40 inches long by 8 inches wide and 2 inches tall. Each curb segment was constructed of a single section. The curb was attached to the roadway surface at two bolting locations at either end of the segment. The test installation utilized two ½-inch wedge bolts to anchor each curb section. A 12.3-inch long by 8-inch wide coupler was used to couple successive segments together. The test installation was constructed in a 30-degree “V” formation. The longer leg of the “V” was constructed using 40 sections and 39 couplers with no gap between segments (133 ft-4 inches). The shorter leg of the “V” was constructed using 10 segments with no gap between segments (33 ft-4 inches). A single 36-inch delineator (Model: TP36FQR) with single quick release pin was installed in each segment location. For further details see detail drawings in Attachment A.

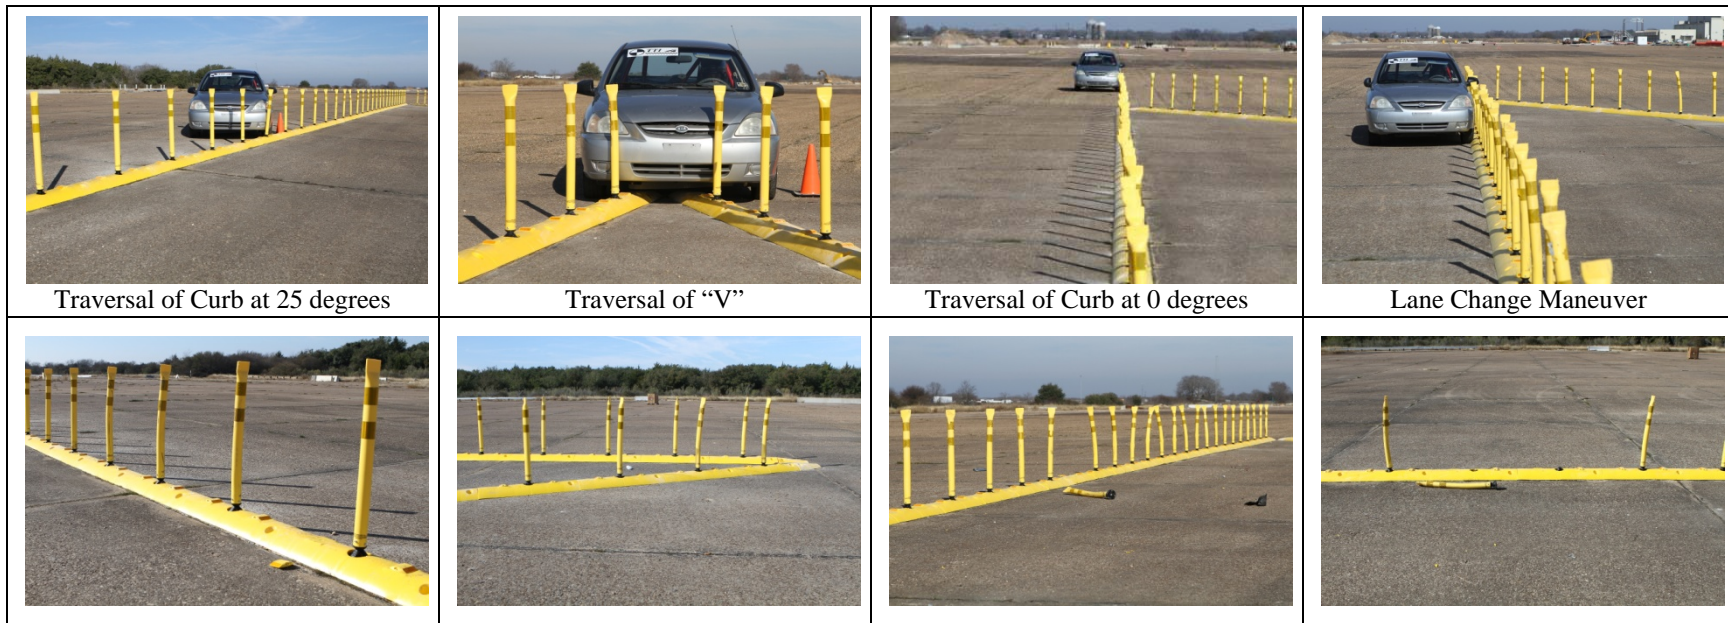
Test Agency..... Texas Transportation Institute
 Test Standard Test No. MASH 3-90
 Test No. 400001-IRS6-5 through IRS6-8
 Date 2011-01-19

Type..... Curb/Longitudinal Channelizer
 Name Tuff Curb
 Installation Length 133 ft on long leg, 33 ft on short leg
 Material or Key Elements High-Density Polyethylene 3.5 inches tall x
 12 inches wide x 40 inches long anchored with
 4-inch x 1/2-inch wedge bolts

Designation.....1100C
 Model.....2004 Kia Rio
 Mass
 Curb.....2310 lb
 Test Inertial.....2310 lb
 Driver.....190 lb
 Gross Static.....2500 lb

Speed62 mi/h
 AngleVaries as above

Exterior
 VDS..... N/A
 CDC 12UDFW1
 Max. Exterior
 Vehicle Crush..... 0
 Interior
 OCDI FS0000000
 Max. Occupant Compartment
 Deformation 0

Figure 3. Summary of results for *MASH* test 3-90 on the Tuff Curb.

MASH Evaluation Criteria	Test Results	Assessment
Structural Adequacy		
C. <i>Acceptable test article performance may be by redirection, controlled penetration, or controlled stopping of the vehicle.</i>	In all maneuvers, the 1100C vehicle penetrated the Tuff Curb installation.	Pass
Occupant Risk D. <i>Detached elements, fragments, or other debris from the test article should not penetrate or show potential for penetrating the occupant compartment, or present an undue hazard to other traffic, pedestrians, or personnel in a work zone.</i> <i>Deformations of, or intrusions into, the occupant compartment should not exceed limits set forth in Section 5.3 and Appendix E of MASH.</i>	Only very small, if any, debris were present during any of the maneuvers. However, these debris did not penetrate, show potential for penetrating, nor to present undue hazard to others in the area. No occupant compartment deformations or intrusions occurred during any of the maneuvers with the 1100C vehicle.	Pass Pass

N. <i>Vehicle trajectory behind the test article is acceptable.</i>	The 1100C vehicle exited behind the installation.	Pass

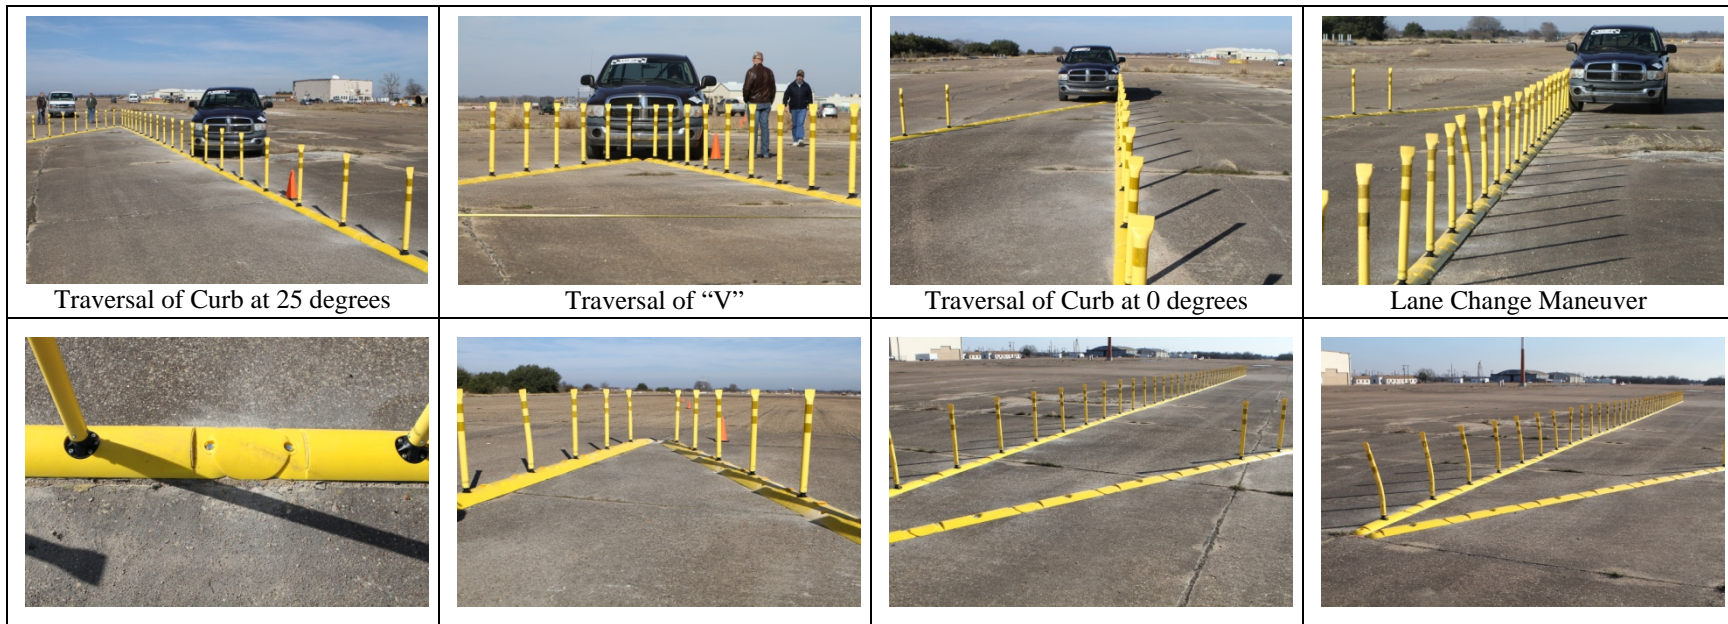
Test Agency..... Texas Transportation Institute
 Test Standard Test No. MASH 3-91
 Test No. 400001-IRS6-9 through IRS6-12
 Date 2011-01-19

Type..... Curb/Longitudinal Channelizer
 Name Tuff Curb XLP with Coupler
 Installation Length 140 ft on long leg, 35 ft on short leg
 Material or Key Elements High-Density Polyethylene 2 inches tall x 8 inches wide x 40 inches long anchored with 4-inch x 1/2-inch wedge bolts

Designation.....2270P
 Model.....2003 Dodge Ram 1500
 Mass
 Curb.....4760 lb
 Test Inertial.....4760 lb
 Driver..... 190 lb
 Gross Static.....4950 lb

Speed62 mi/h
 AngleVaries as above

Exterior
 VDS.....N/A
 CDC12UDFW1
 Max. Exterior
 Vehicle Crush.....0
 Interior
 OCDIFS000000
 Max. Occupant Compartment
 Deformation.....0

Figure 4. Summary of results for *MASH* test 3-91 on the Tuff Curb XLP with Coupler.

MASH Evaluation Criteria	Test Results	Assessment
Structural Adequacy		
<i>C. Acceptable test article performance may be by redirection, controlled penetration, or controlled stopping of the vehicle.</i>	In all maneuvers, the 2270P vehicle penetrated the Tuff Curb XLP installation.	Pass
Occupant Risk		
<i>D. Detached elements, fragments, or other debris from the test article should not penetrate or show potential for penetrating the occupant compartment, or present an undue hazard to other traffic, pedestrians, or personnel in a work zone. Deformations of, or intrusions into, the occupant compartment should not exceed limits set forth in Section 5.3 and Appendix E of MASH.</i>	Only very small, if any, debris were present during any of the maneuvers. However, these debris did not penetrate, show potential for penetrating, nor to present undue hazard to others in the area. No occupant compartment deformations or intrusions occurred during any of the maneuvers with the 2270P vehicle.	Pass Pass

Vehicle Trajectory		
<i>N. Vehicle trajectory behind the test article is acceptable.</i>	The 2270P vehicle exited behind the installation.	Pass

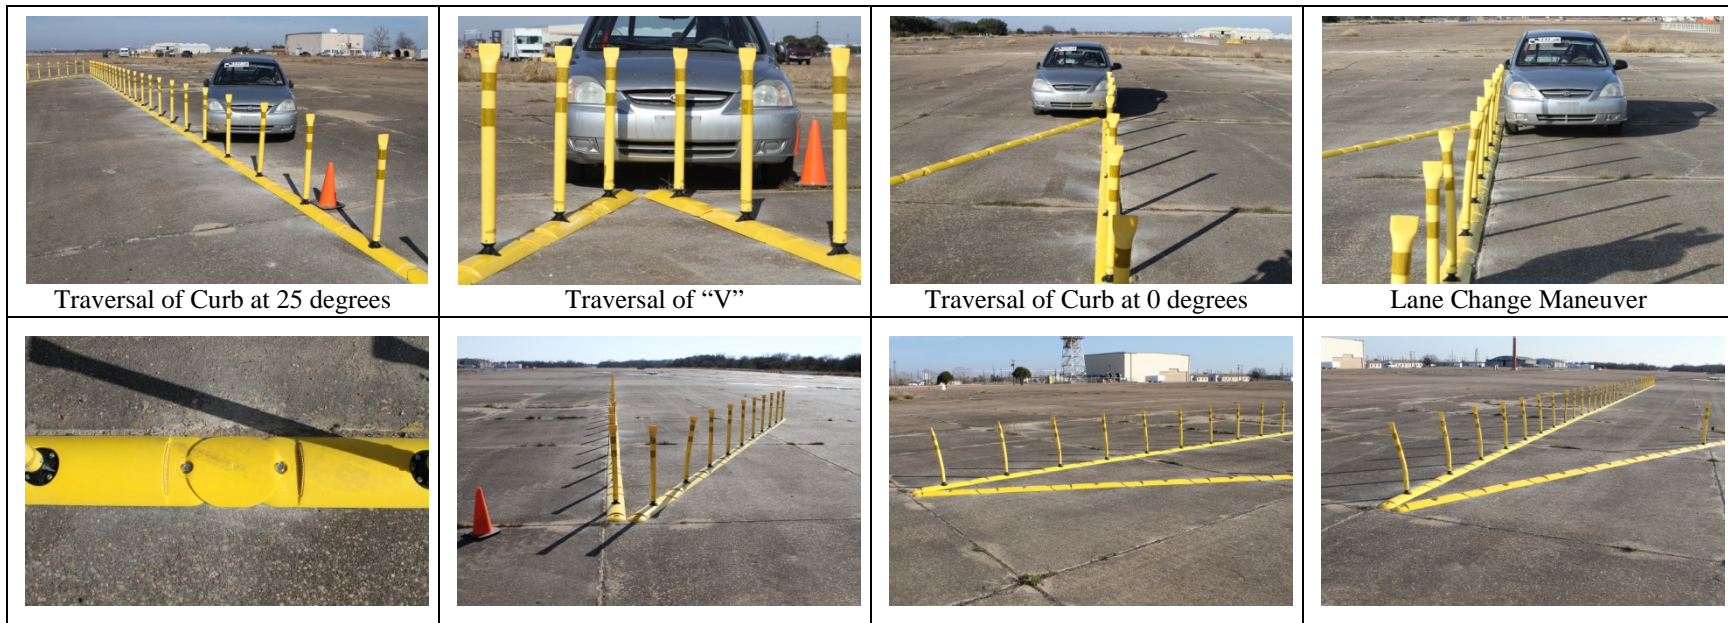
Test Agency..... Texas Transportation Institute
 Test Standard Test No. MASH 3-90
 Test No. 400001-IRS6-13 through IRS6-16
 Date 2011-01-19

Type..... Curb/Longitudinal Channelizer
 Name Tuff Curb XLP with Coupler
 Installation Length 140 ft on long leg, 35 ft on short leg
 Material or Key Elements High-Density Polyethylene 2 inches tall x 8 inches wide x 40 inches long anchored with 4-inch x 1/2-inch wedge bolts

Designation.....1100C
 Model.....2004 Kia Rio
 Mass
 Curb.....2310 lb
 Test Inertial.....2310 lb
 Driver.....190 lb
 Gross Static.....2500 lb

Speed62 mi/h
 AngleVaries as above

Exterior
 VDS..... N/A
 CDC 12UDFW1
 Max. Exterior
 Vehicle Crush..... 0
 Interior
 OCDI FS0000000
 Max. Occupant Compartment
 Deformation 0

Figure 3. Summary of results for *MASH* test 3-90 on the Tuff Curb XLP with Coupler.

MASH Evaluation Criteria	Test Results	Assessment
Structural Adequacy		
C. <i>Acceptable test article performance may be by redirection, controlled penetration, or controlled stopping of the vehicle.</i>	In all maneuvers, the 1100C vehicle penetrated the Tuff Curb XLP installation.	Pass
Occupant Risk

N. <i>Vehicle trajectory behind the test article is acceptable.</i>	The 1100C vehicle exited behind the installation.	Pass

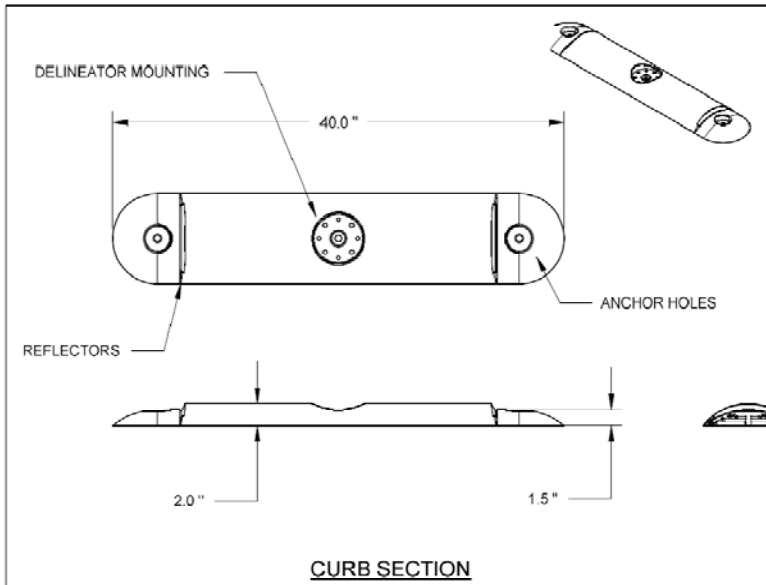
CURB SECTION

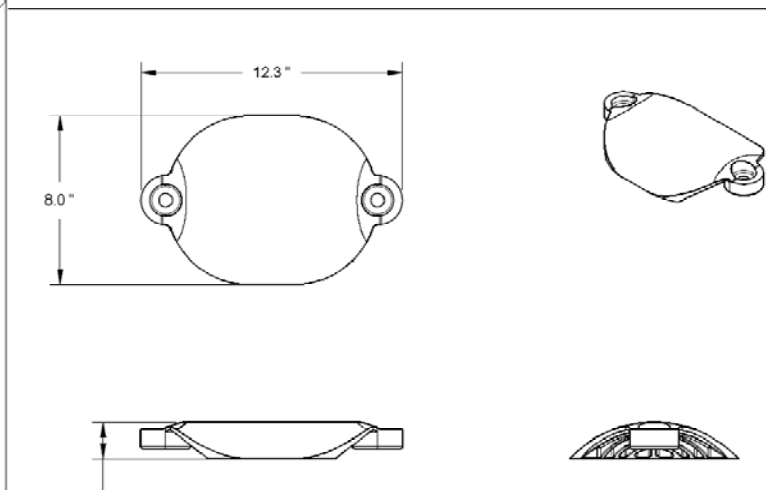
COUPLER

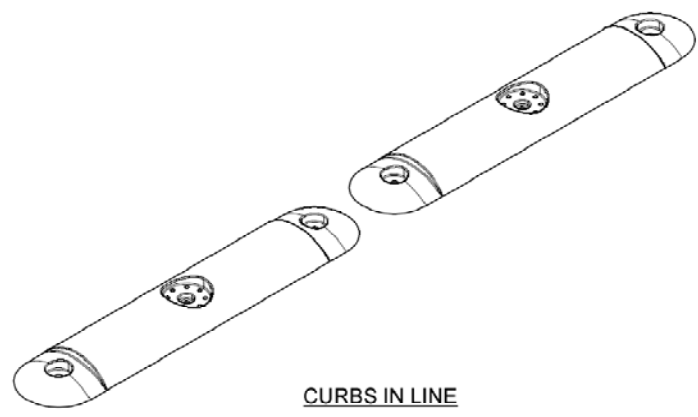
CURBS IN LINE

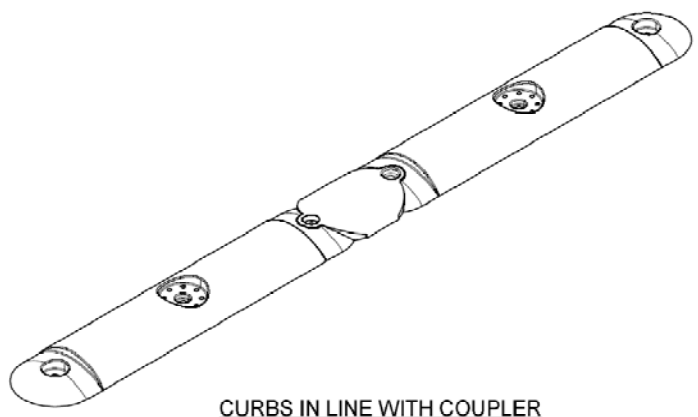
CURBS IN LINE WITH COUPLER

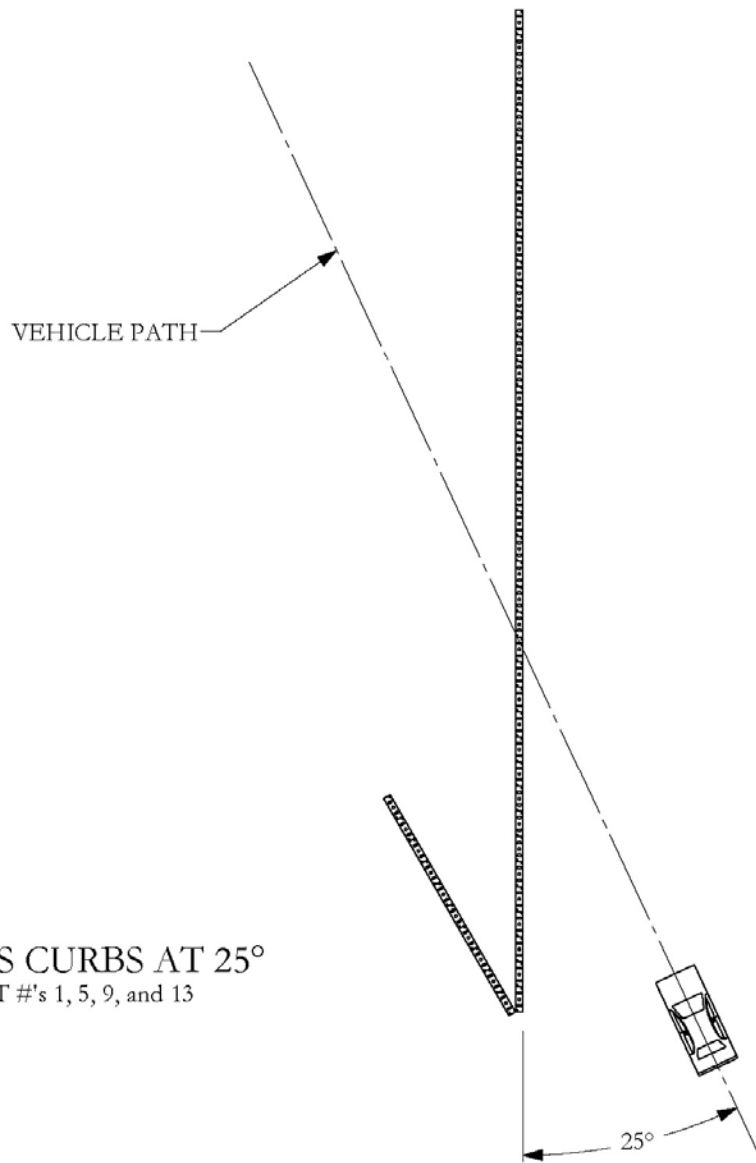
CROSS CURBS AT 25°
TEST #'s 1, 5, 9, and 13

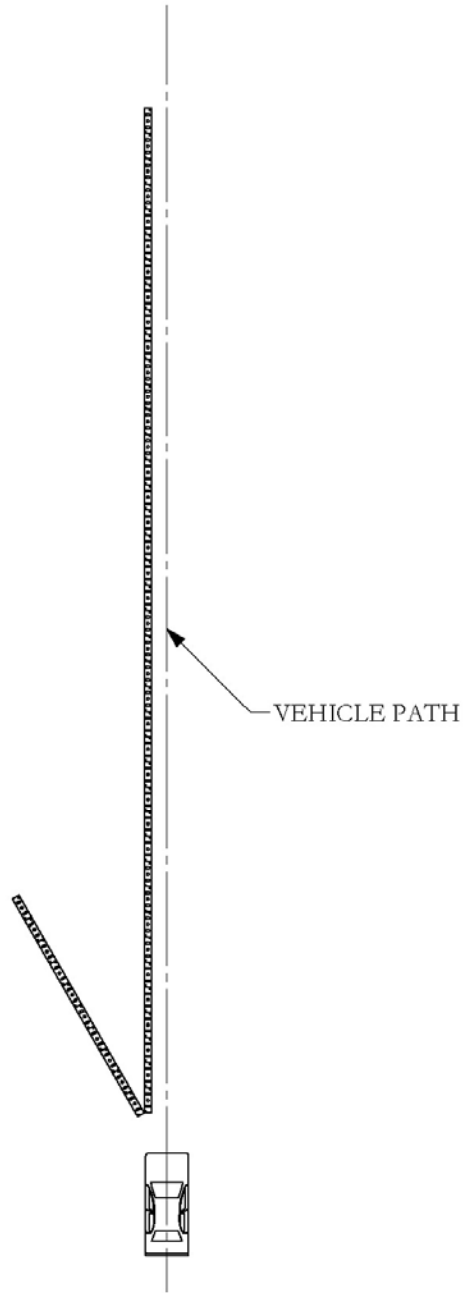
DRIVER'S SIDE TIRE ON CURBS
 TEST #'s 3, 7, 11, and 15

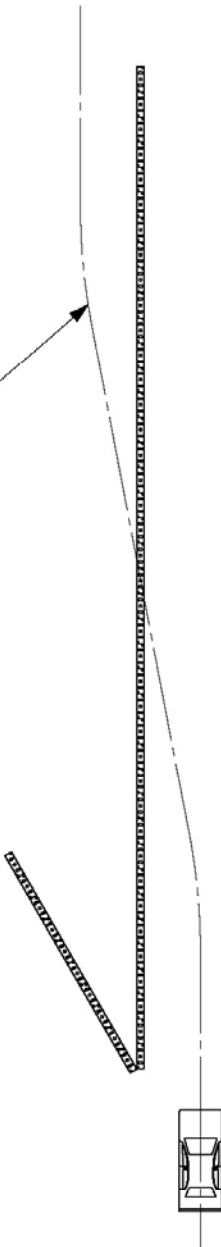
VEHICLE PATH

LANE CHANGE
TEST #'s 4, 8, 12, and 16
