**REPORT OF  
WINTER 1996/SUMMER 1996  
FLEXIBLE DELINEATOR  
IMPACT TESTING**

**NTPEP 124**

**October 1996**

**TENNESSEE DEPARTMENT OF TRANSPORTATION**

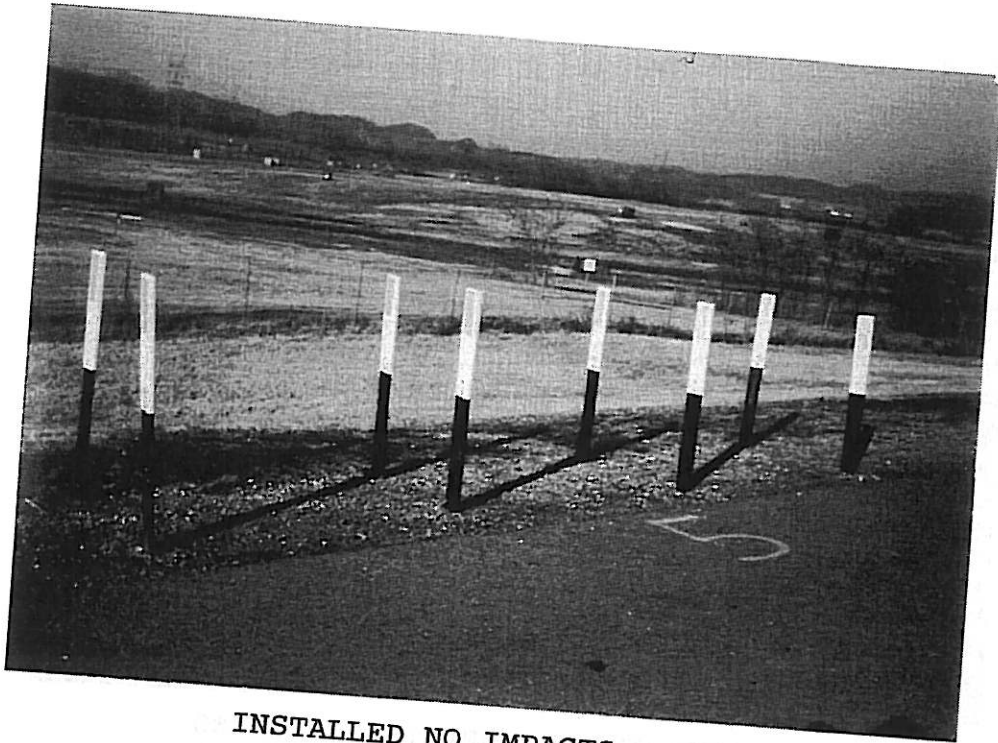
KENNCO HDPE EXTRUSION

INSTALLED NO IMPACTS

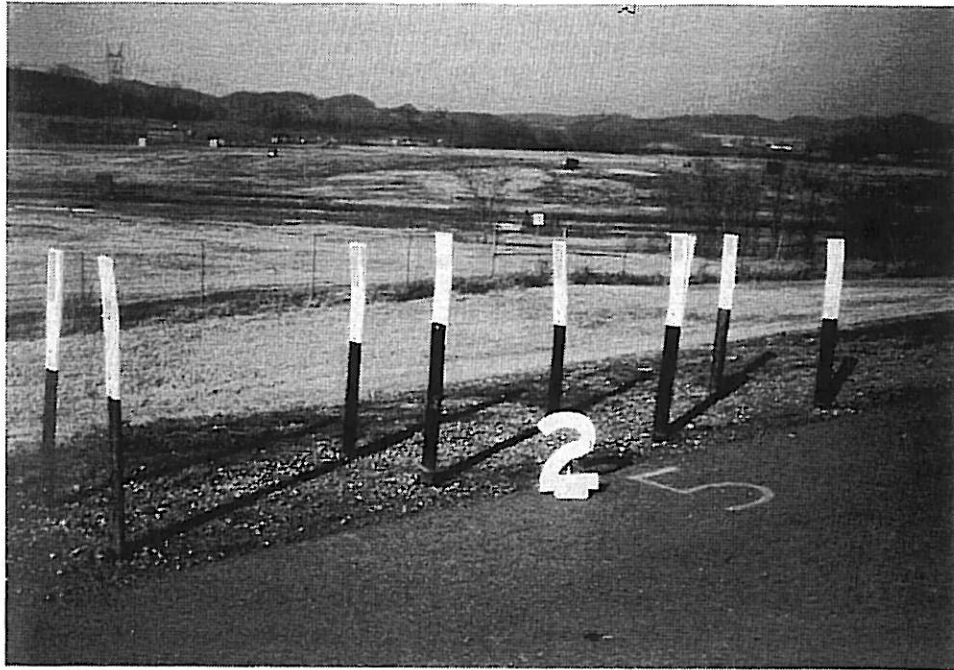
KENNCO HDPE EXTRUSION

TWO WINTER IMPACTS COMPLETED

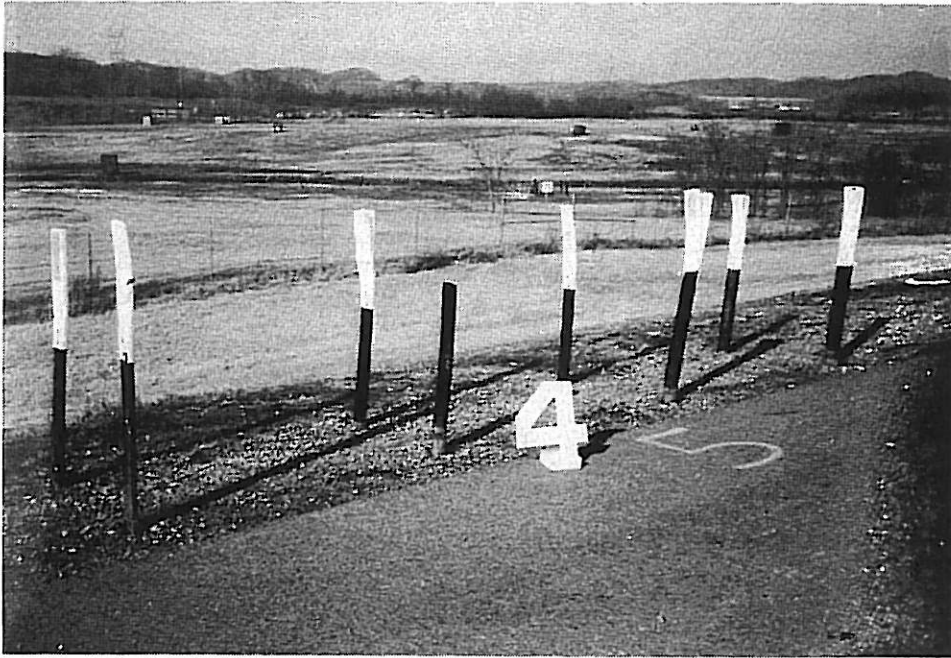
KENNCO HDPE EXTRUSION

FOUR WINTER IMPACTS COMPLETED

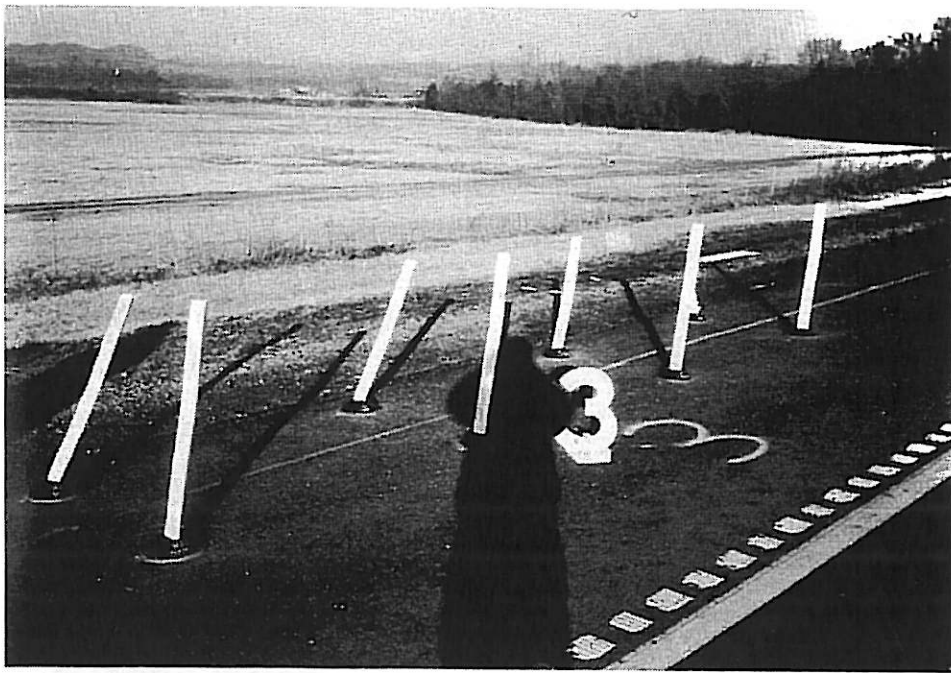
THREE WINTER IMPACTS COMPLETED

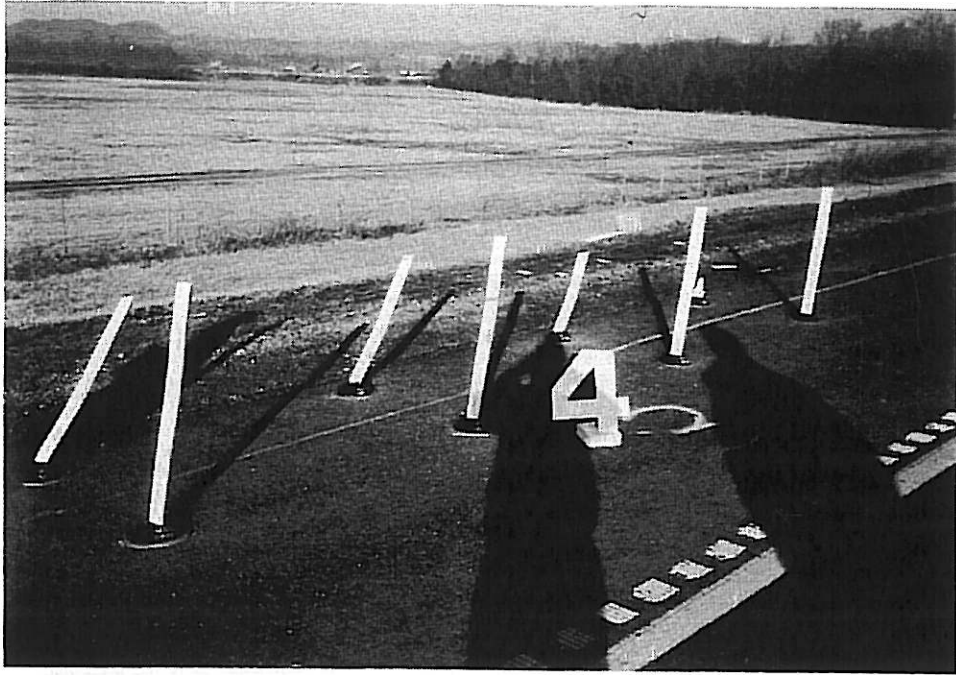
FOUR WINTER IMPACTS COMPLETED

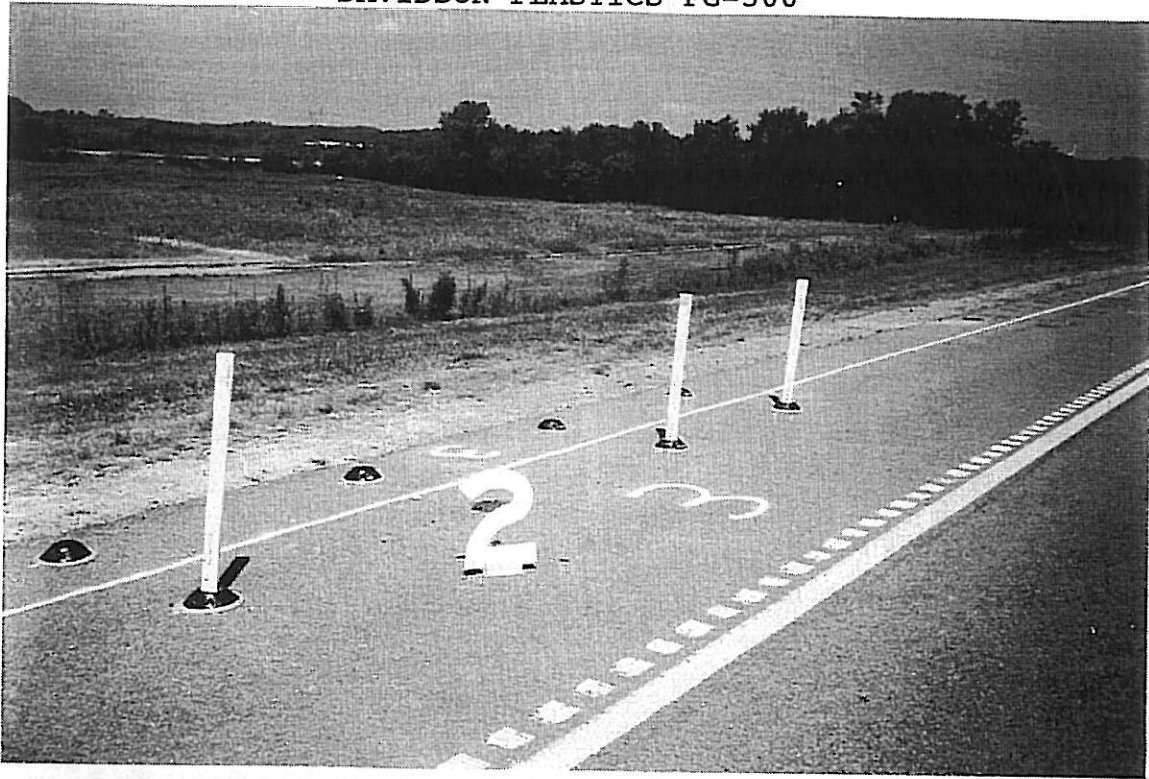
FIVE WINTER IMPACTS COMPLETED  
TWO SUMMER IMPACTS COMPLETED
